**APPENDIX 11 – Chevrolet S-10 Service Bulletins**

*Electric Transportation Applications*

# Service Bulletin

**Subject: Replacing Refrigerant Label**

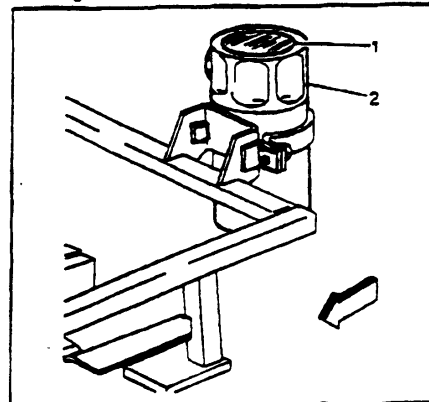
Figure 1 - Accumulator Label Location

On 1997-98 S-10 Electric Trucks, the existing refrigerant label on the evaporator and blower motor assembly shows an incorrect refrigerant oil part number. The correct refrigerant oil part number is Z7002486.

**Notice:** Using the incorrect oil for A/C system repair will damage the refrigerant system.

Replace the existing refrigerant label, GM P/N 52474699, with a new label on the evaporator and blower motor housing. Use the part number listed below. Use the following Service Procedure in order to replace the label:

1. Remove the old label from the accumulator, if equipped. Use a utility knife or remove improper refrigerant specification wording from the label (Figure 1).
2. Remove the existing refrigerant label, GM P/N 52474699, from the evaporator and blower assembly.
3. Clean the label surface area on the evaporator and blower motor assembly before affixing the label.
4. Affix the new label on the blower motor housing. Position the label so that the label can be read from the front of the vehicle (Figures 2, 3).

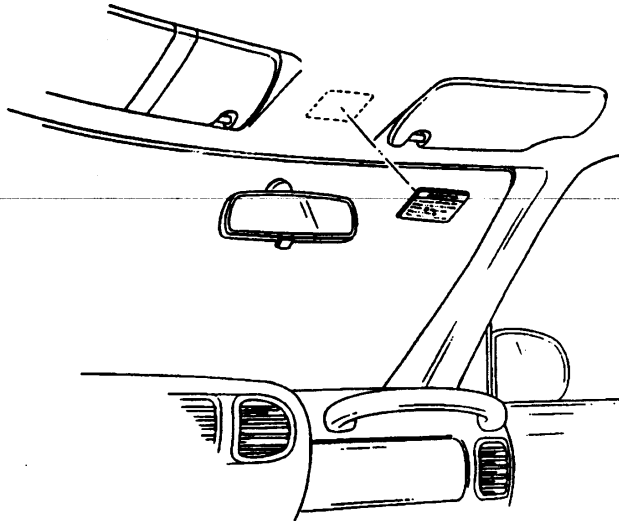
Figure 1 - Caution Label Installation

General Motors has decided that a defect which relates to motor vehicle safety exists in 1997-98 Chevrolet S-10 trucks with electric drive. Rapid fogging of the interior glass can occur within two minutes after the heat is turned on if (1) the outside temperature is between 35 and 76 degrees Fahrenheit and (2) water has collected on the heat exchanger during previous operation of the air conditioning (water can remain there even several days after the air conditioning was used). If rapid fogging were to occur during driving, it could obstruct the driver's vision and lead to a crash without prior warning.

1. Insure mounting surface is clean.
2. Install caution label on headliner centered between visors as shown in Figure 1 below.
