Presentation 1. INL Experience With Vehicle Thermal Events

Battery Safety Council Safety Technical Discussion on The Suppression of Battery Fires Washington, DC April 2016

INL Experience with "Thermal Anomalies"

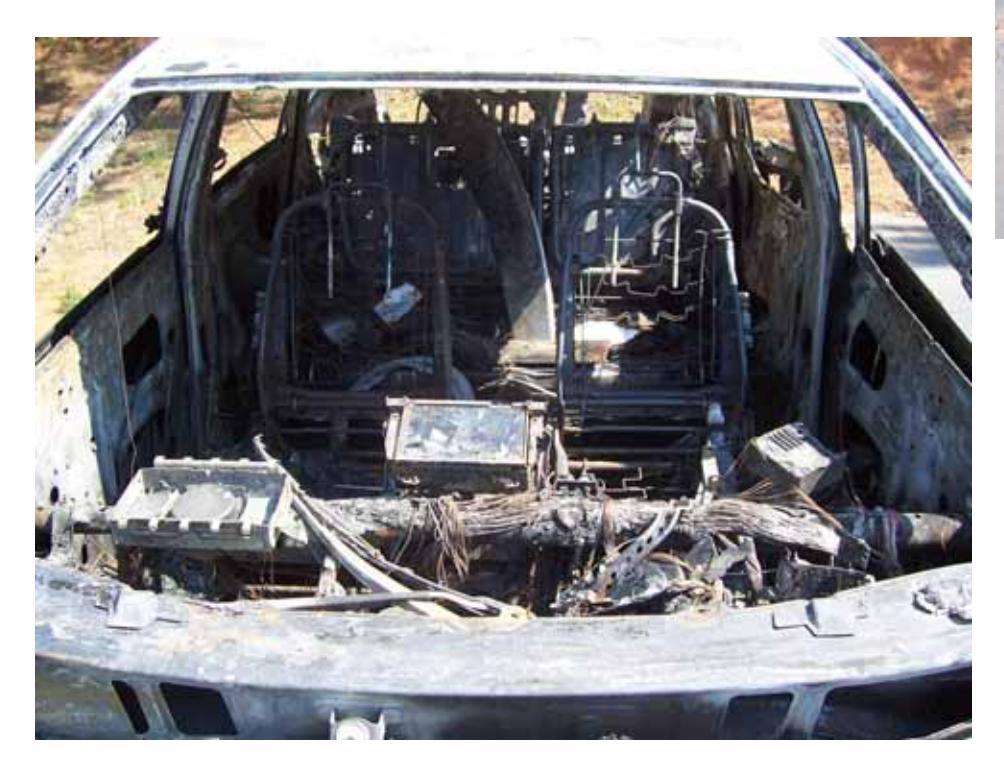
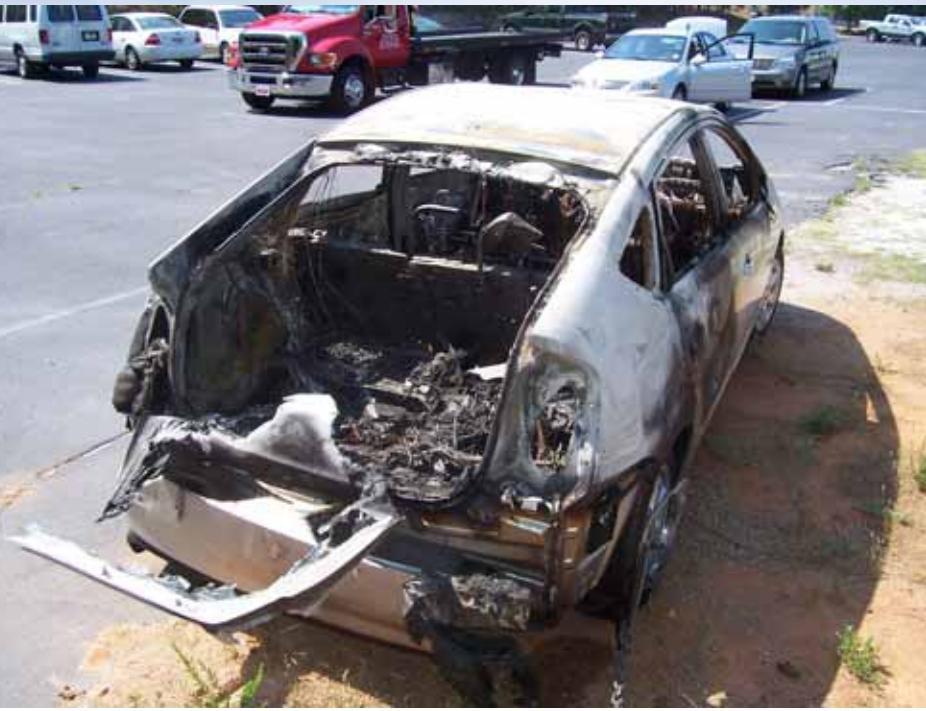
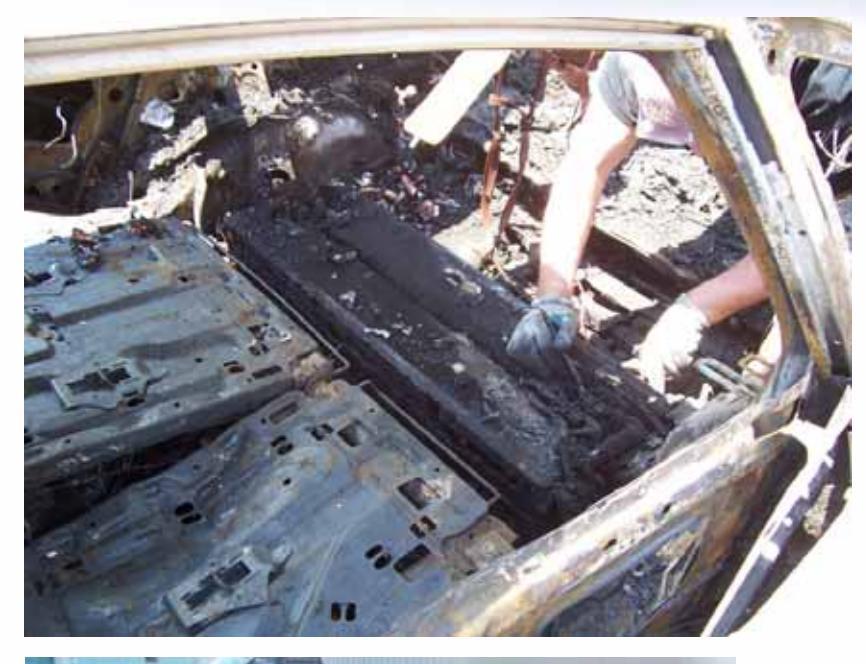
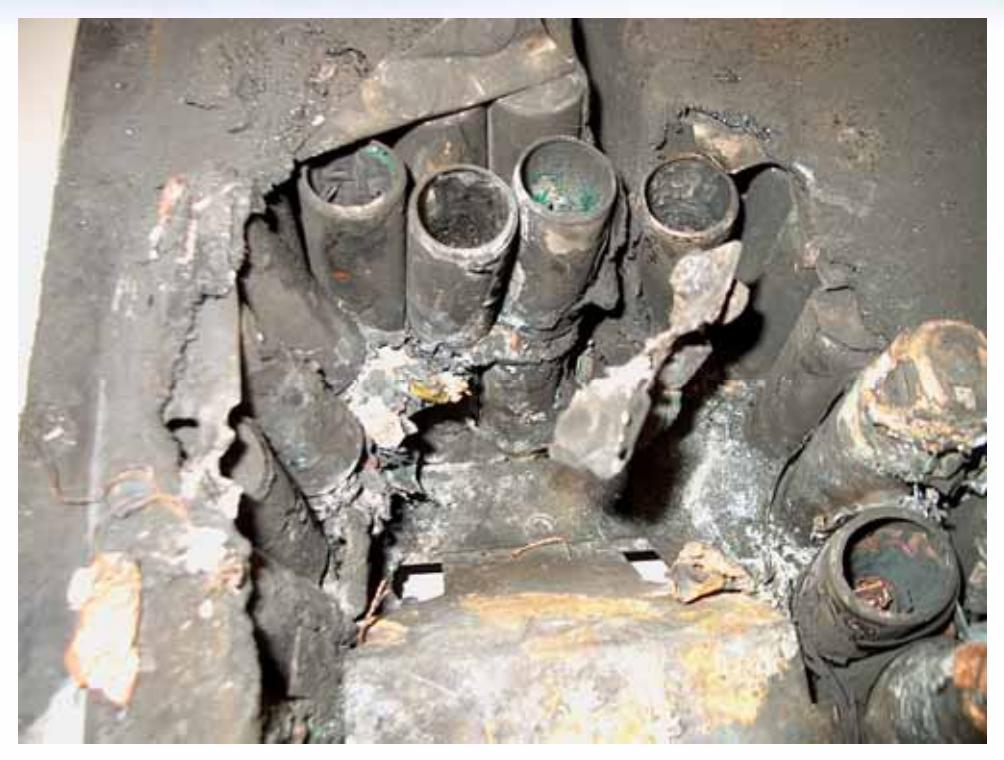
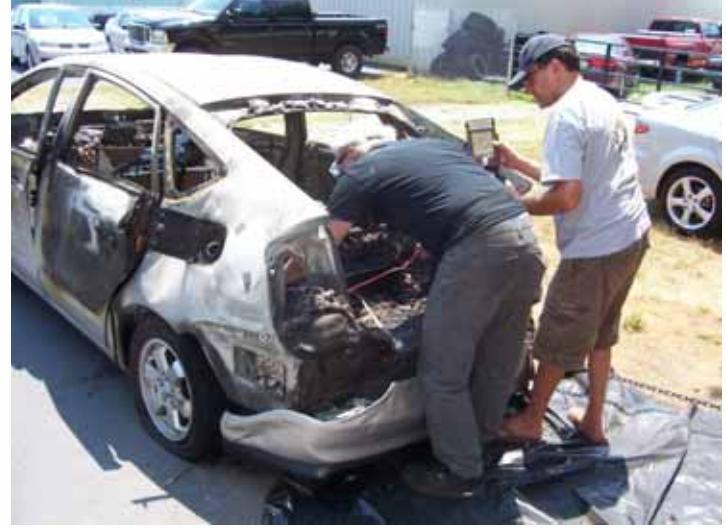
Third Party Conversion of a HEV Sedan to a PHEV

- Conversion company used a Prius as the base vehicle and converted it into a PHEV-15 with a lithium ion mule battery
- Smoke filled the vehicle cabin while the vehicle was being driven
- Driver pulled over and noted fire in the right side of the rear cargo compartment. The vehicle was consumed (see pictures)
- Event occurred in a rural area and there was no fire suppression
- The conversion company did not follow the battery manufacturer's guidelines when designing and building their packs
- Likely cause was a loose high voltage connection within the battery enclosure, not a battery cell specific caused event
- At autopsy, high voltage was still present in the damaged battery
- Next pages show that the battery survived the event fairly well
- Note sandals and lack of personal protection equipment on conversation company staff

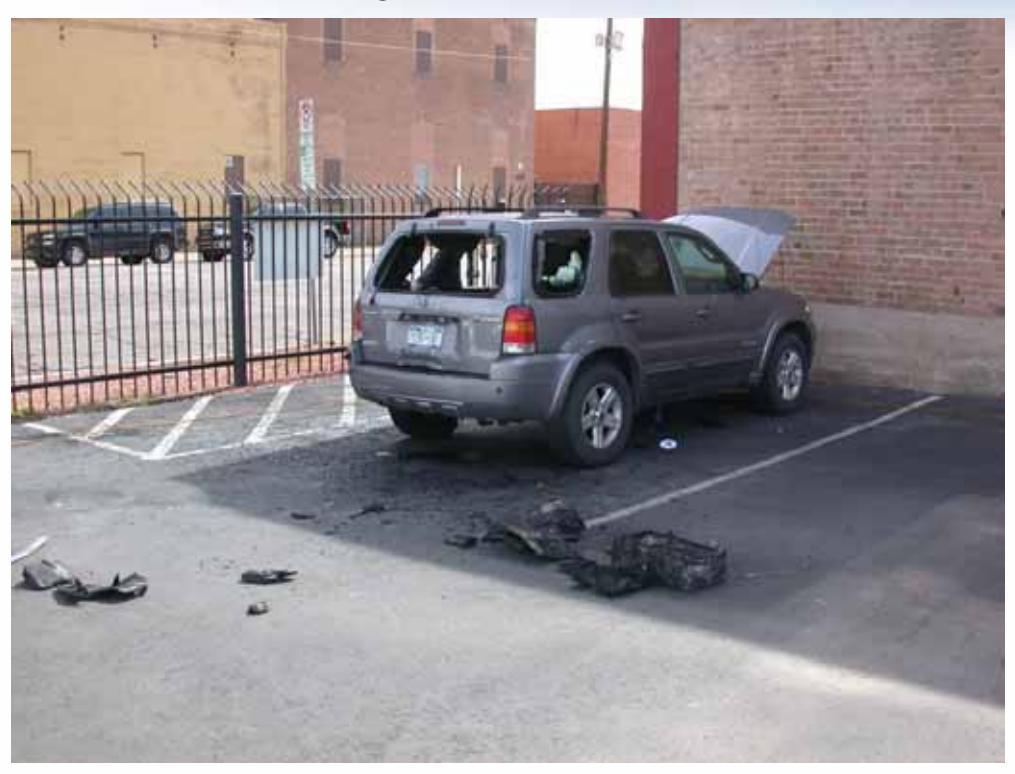
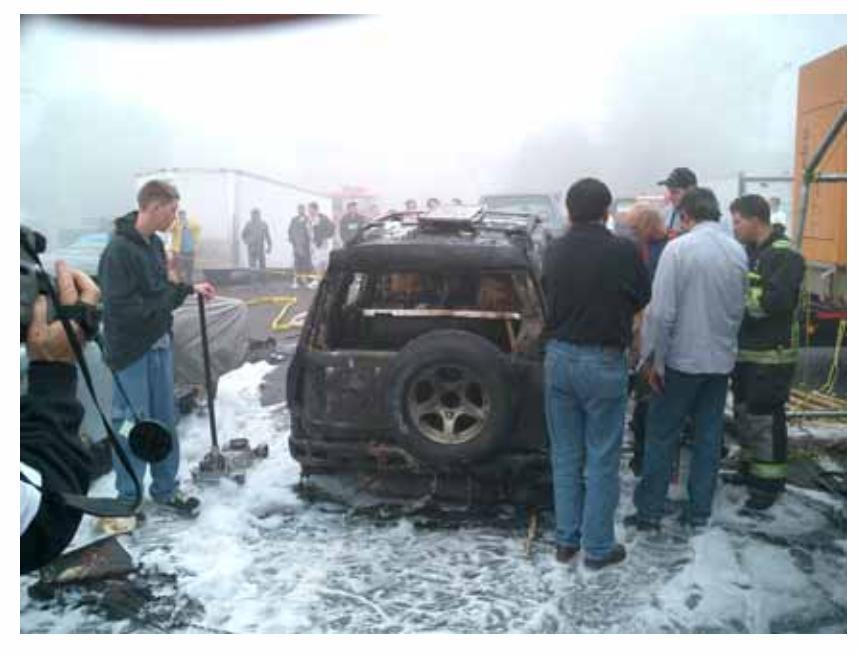
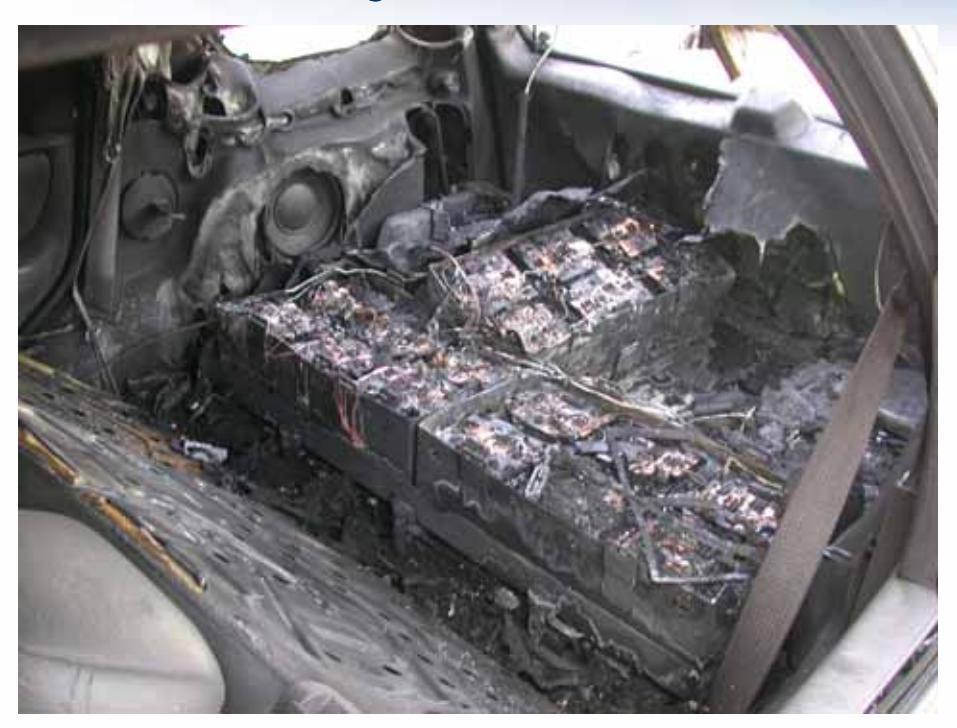
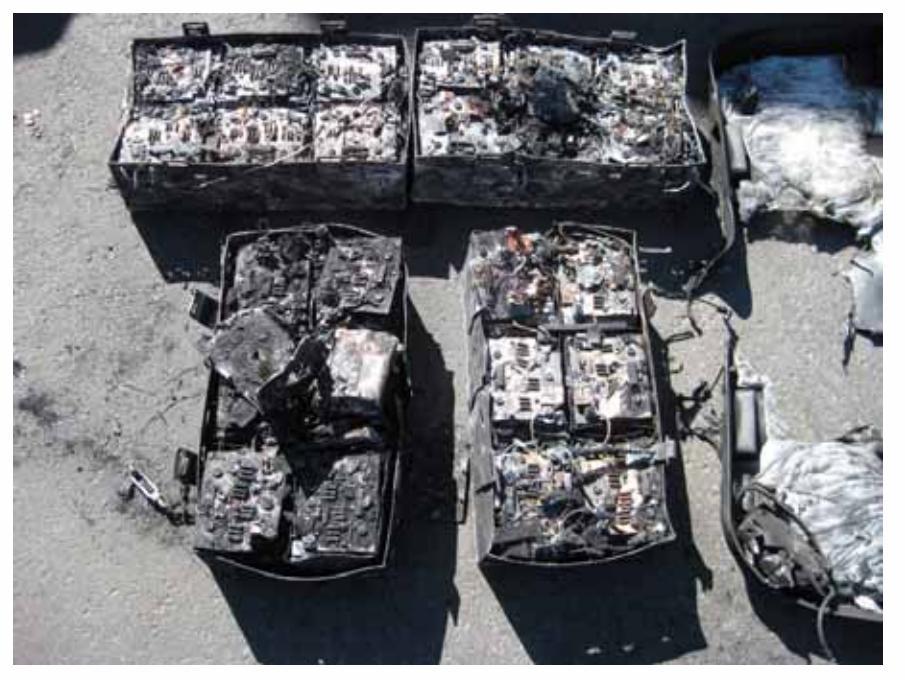
Third Party Conversion of a HEV SUV to a PHEV

- INL was benchmarking a conversion HEV SUV to a PHEV in Phoenix
- Conversion company used a HEV SUV as the base vehicle and added their own 12 KWh lithium ion mule battery

- Vehicle was parked overnight in a fenced area. A security guard called the fire department when smoke was observed at approximately 2 a.m.
- Vehicle did not catch "fire" (insert offline comment here) but suffered extensive heat and smoke damage

- It is believed high voltage was still present in the damaged battery when the Phoenix fire department forcibly removed part of the pack and applied water to the pack and vehicle

- Cause was over-charge events, caused by onboard battery charger or BMS failure – per review of data logger data indicating a 15 kWh charge occurred pre event. Cells significantly overheated

- Partial pack removal stopped overcharging and internal shorting, while water cooled the pack
- Bottom right (next page) is the same converter's PHEV at a student competition

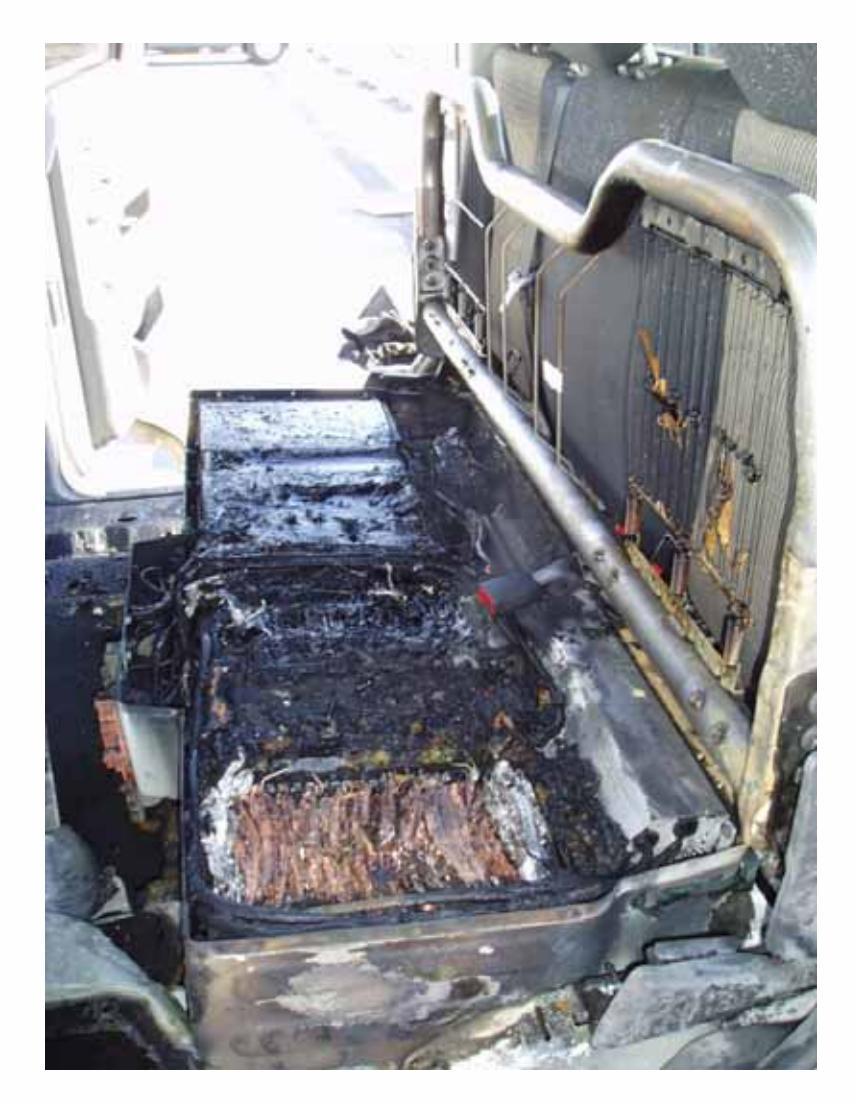
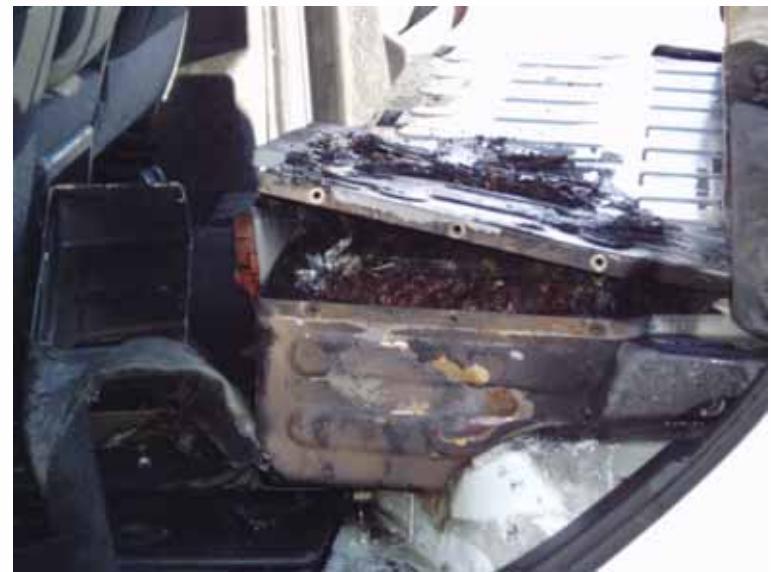
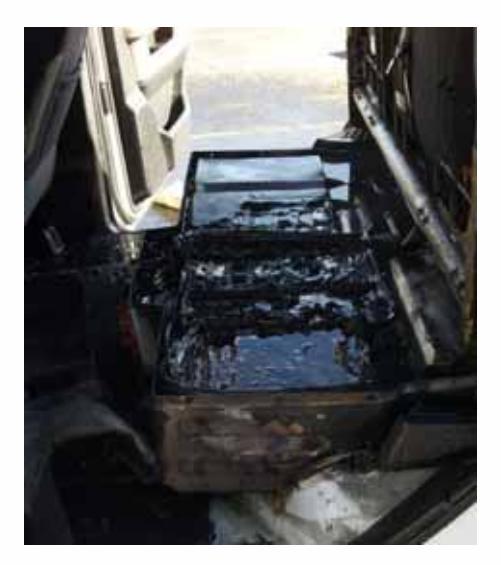
OEM Preproduction PHEV @ INL

The 12 KWh lithium ion traction battery was installed under the back seat of the crew cab pickup

- Vehicle was shipped off site for autopsy with vermiculite on top of the pack as a further safety step
- INL's and two additional events with same PHEV model were likely caused by pack design and wiring decisions, not actual cell problems

- INL event: Not properly insulating wires used for diagnostics after the wires where cut before installing the packs into the vehicles
 - Second event: High and low voltage wires rubbing together in same wiring bundle during vehicle operations induced vibration.
 High voltage flowed into low voltage pack diagnostics and cells

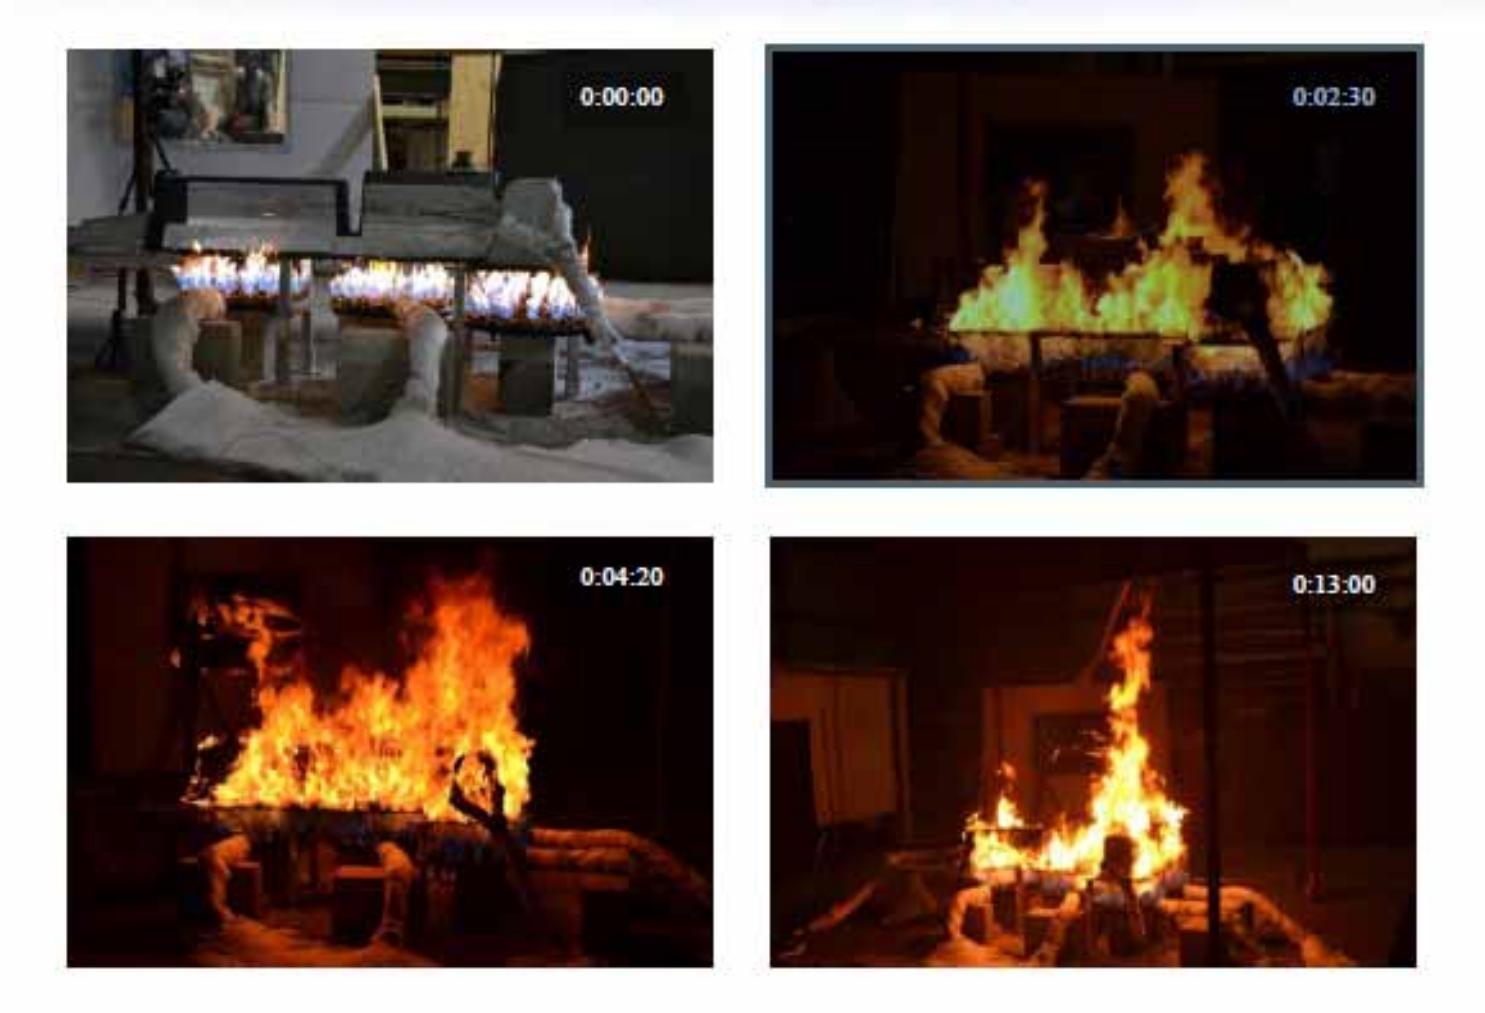
Figure 50 0 minutes (top left), 2:30 minutes (top right), 4:20 minutes (bottom left), 13 minutes (bottom right)

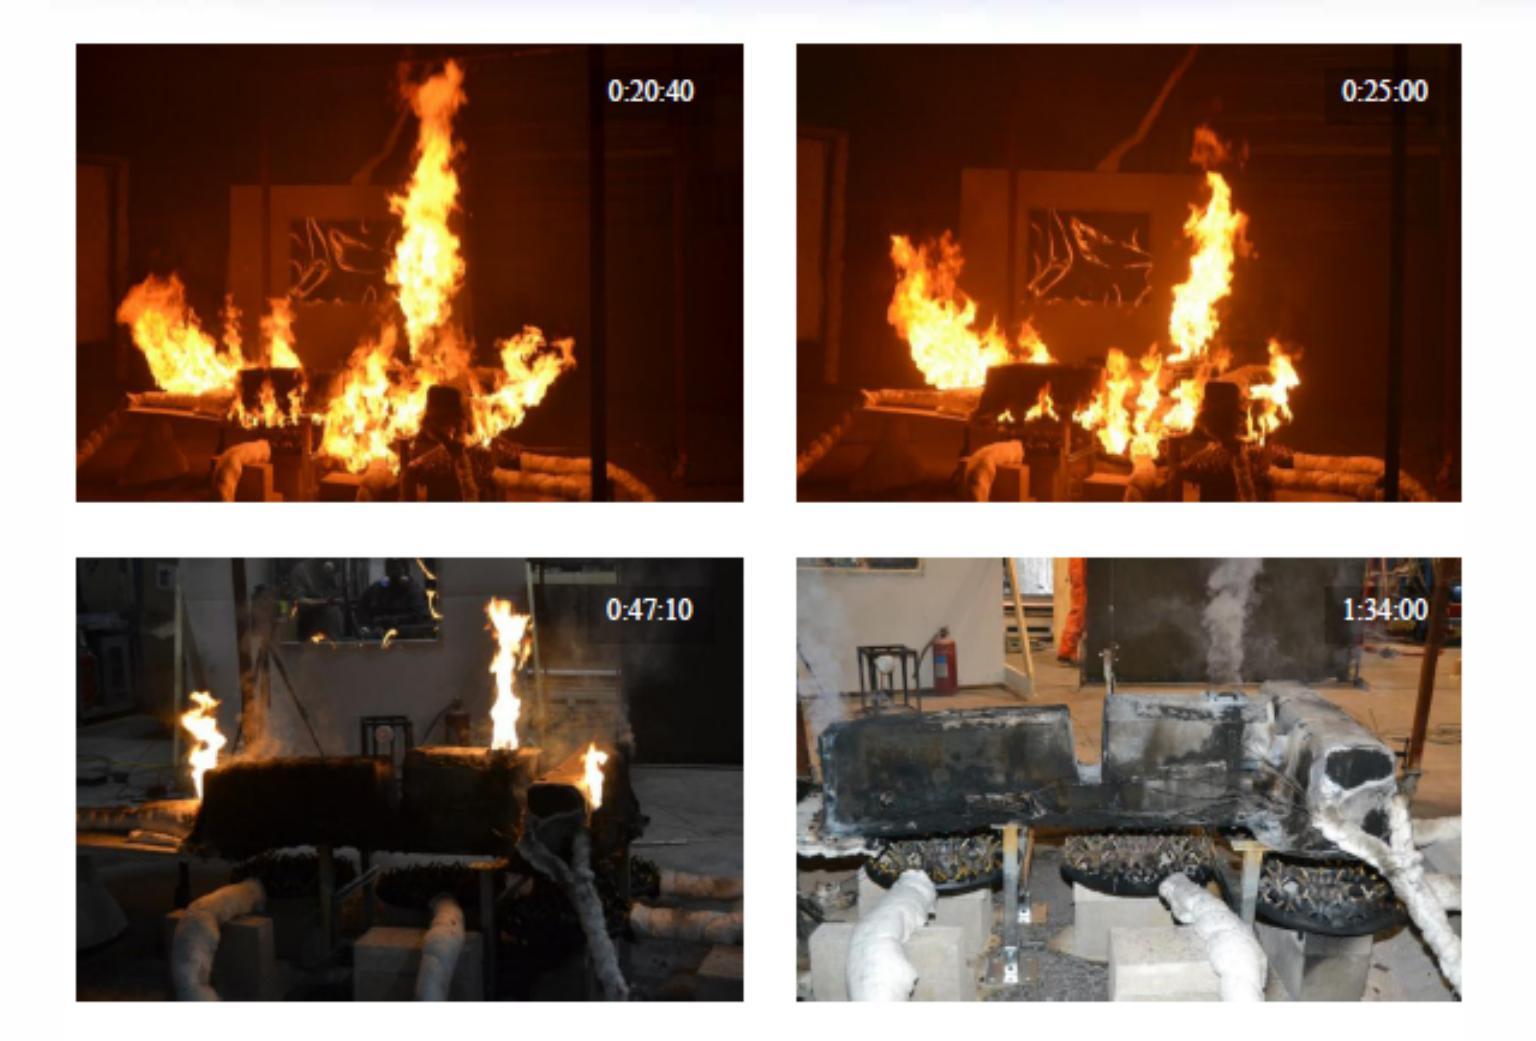
Figure 52 20:40 minutes (top left), 25:00 minutes (top right), 47:10 minutes (bottom left), 01:34:00 minutes (bottom right)

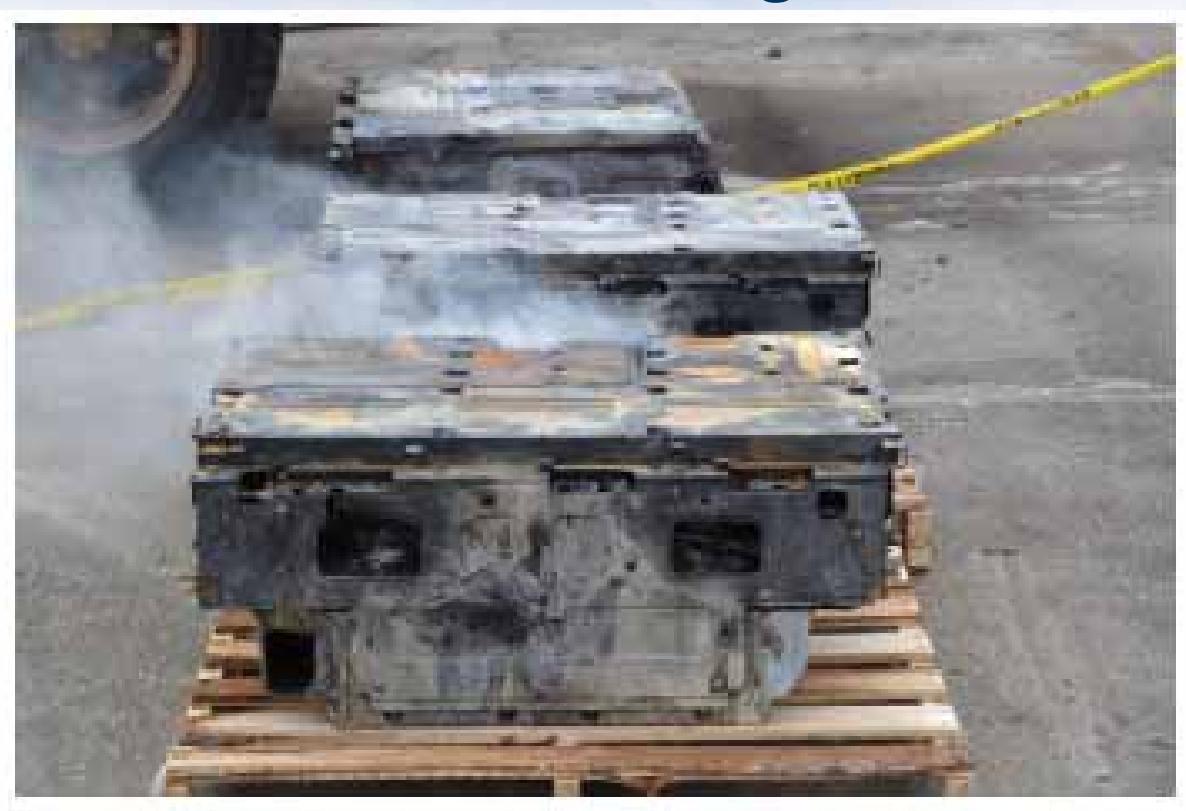
Figure 72 Off gassing of Battery A3 approximately 22 hours after the conclusion of the test

At the conclusion of testing, an OEM's procedures for soaking PEV batteries in a salt bath were followed before shipping the six damaged battery packs. This method requires a minimum of 24 hours of submission
