# Demonstration and Evaluation of U.S. Postal Service Electric Mail Delivery Vehicles

Quarterly Report, December 2000

**Project Number: TC-00-0101**

**Report Number: TC-00-0101-TR02**

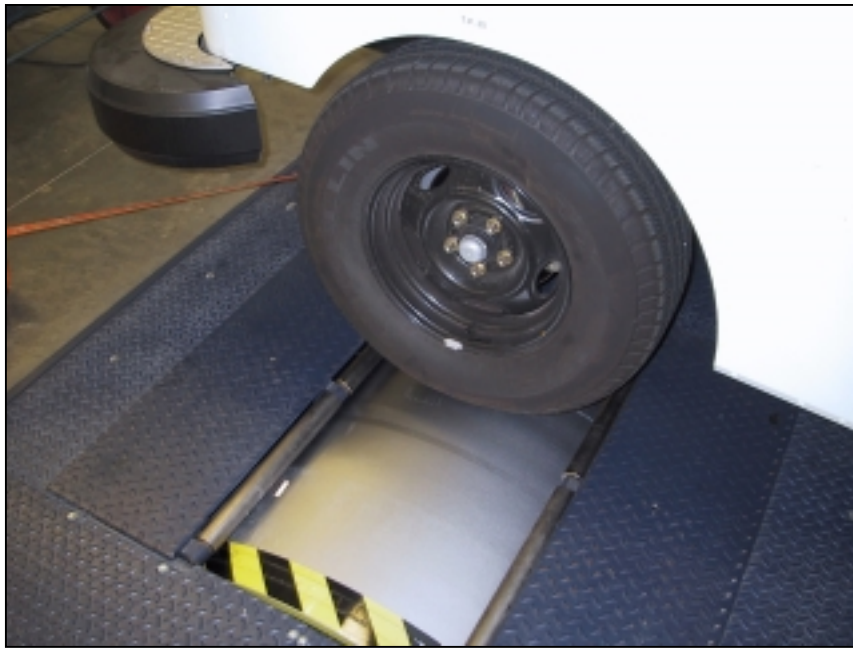
Dynamometer testing was performed at the Mercedes Emissions Testing Facility in Long Beach, California. This test site was chosen because it offered a four-wheel dynamometer, which was necessary in order for the vehicle's anti-lock braking system (ABS) to operate properly. Without tire rotation on the front wheels, the vehicle's regenerative braking does not function due to the ABS system sensing a loss of traction. The figure below shows one of four wheels on top of a 48-inch roller of an AVL/Real Time Instruments four-wheel drive electric inertia dynamometer.

**Figure 1 – 48-inch Roller of an AVL/Real Time Instrument's Electric Dynamometer**

- 10,000 lb maximum inertia
- 200 Horse Power Maximum
- 1150 lb torque up to 65 mph (continuous)
- Maximum torque can be increased by 50% for 60 seconds

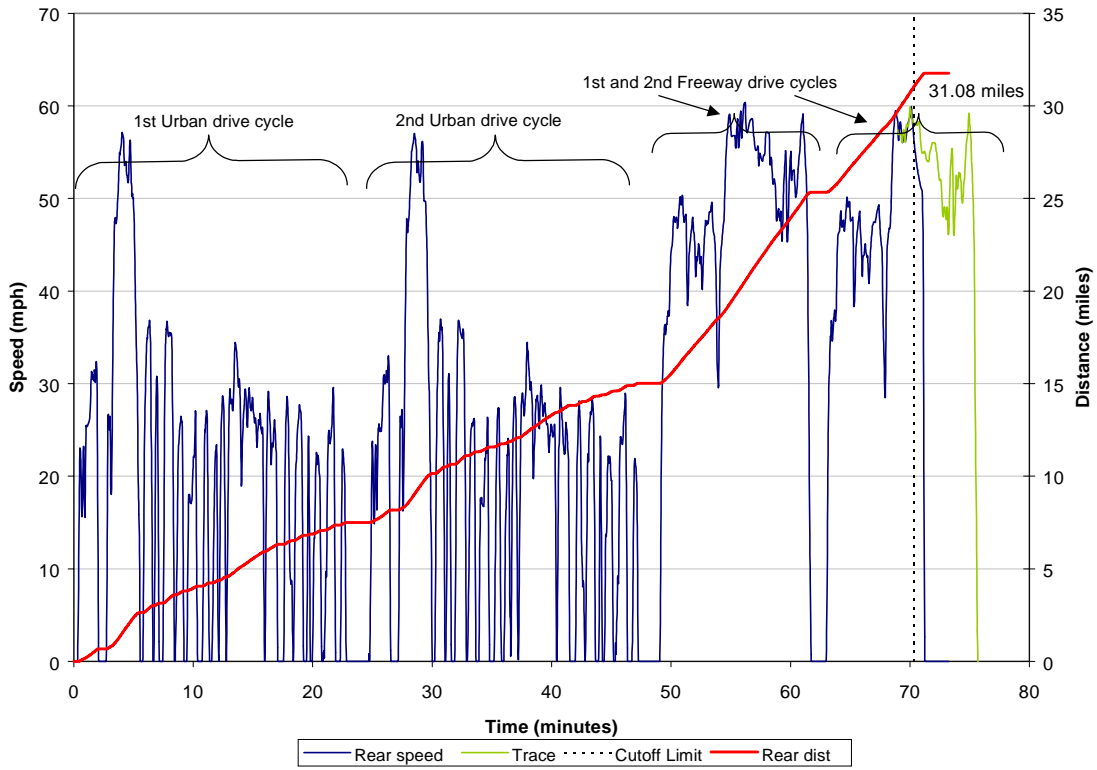
**Figure 4 – Combined UDS/HWFET Drive Profile – Test 1 Vehicle 3**

As can be seen from the previous figures, the postal delivery vehicles averaged 31.1 miles when tested on the combined UDS/HWFET dynamometer cycle. The end of test was determined when the vehicle could no longer follow the trace provided by the dynamometer software. Once the vehicle strayed below 2 mph from the trace, the test was stopped and the mileage was recorded. The table below shows a summary of data that was recorded by the vehicle's on-board data acquisition system as well as the mileage recorded by the dynamometer software.

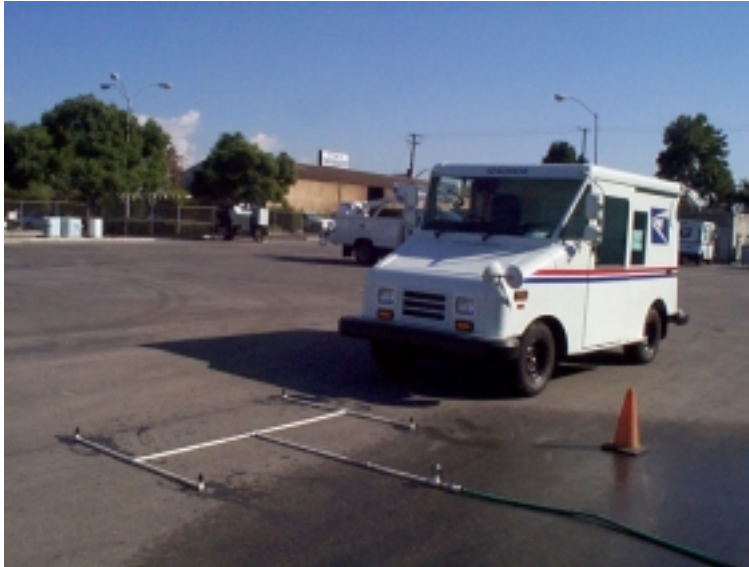
The water test examines the vehicle's ability to endure water hazard conditions in a short time frame. The purpose of this test is to determine the amount of leakage current from battery to chassis and from chassis to ground when the vehicle is driven through a standing water area. To reproduce the effects of splashing water, a sprinkler setup with four sprinkler heads was used for wetting the underside of the vehicle for a ten-minute duration (see photo below).

**Figure 8 – Water Test Setup**

Within five minutes of soaking the underside of the vehicles, they were put on charge and checked for battery leakage current from battery to chassis and from chassis to ground. To access the batteries high voltage leads, a specially designed cover was used at the high voltage junction box that connects the charger and the battery pack. SCE technicians certified to work on Ford electric vehicles performed all high voltage work.

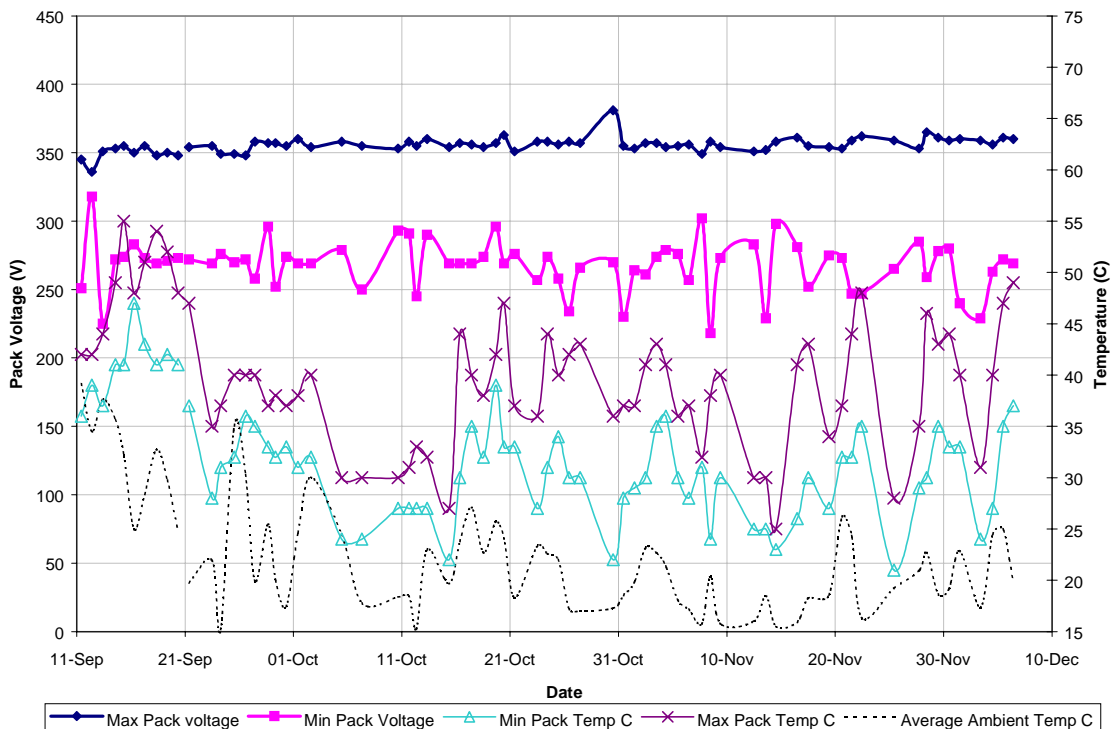
Figure 15 – Pack Voltage and Temperatures While Driving – Vehicle 2 as of 12-6-00

Battery information while driving and while charging is very important for determining how well the pack is performing and what kind of condition they operate in. The on-board data acquisition system is capable of recording battery temperature, battery voltage, and battery energy usage (AC and DC) as well as other relative data. Figures 10 and 11 show the energy usage of vehicles one and two respectively. Figures 12 and 13 show the maximum and minimum voltage and battery temperatures recorded while charging. These plots show that the battery temperatures vary according to ambient temperatures. Figures 14 and 15 show the maximum and minimum voltage and battery temperatures recorded while driving vehicles one and two respectively.
