INL/EXT-05-00040

**U.S. Department of Energy
FreedomCAR & Vehicle Technologies Program**

**Oil Bypass Filter Technology Evaluation
Ninth Quarterly Report
October–December 2004**

February 2005

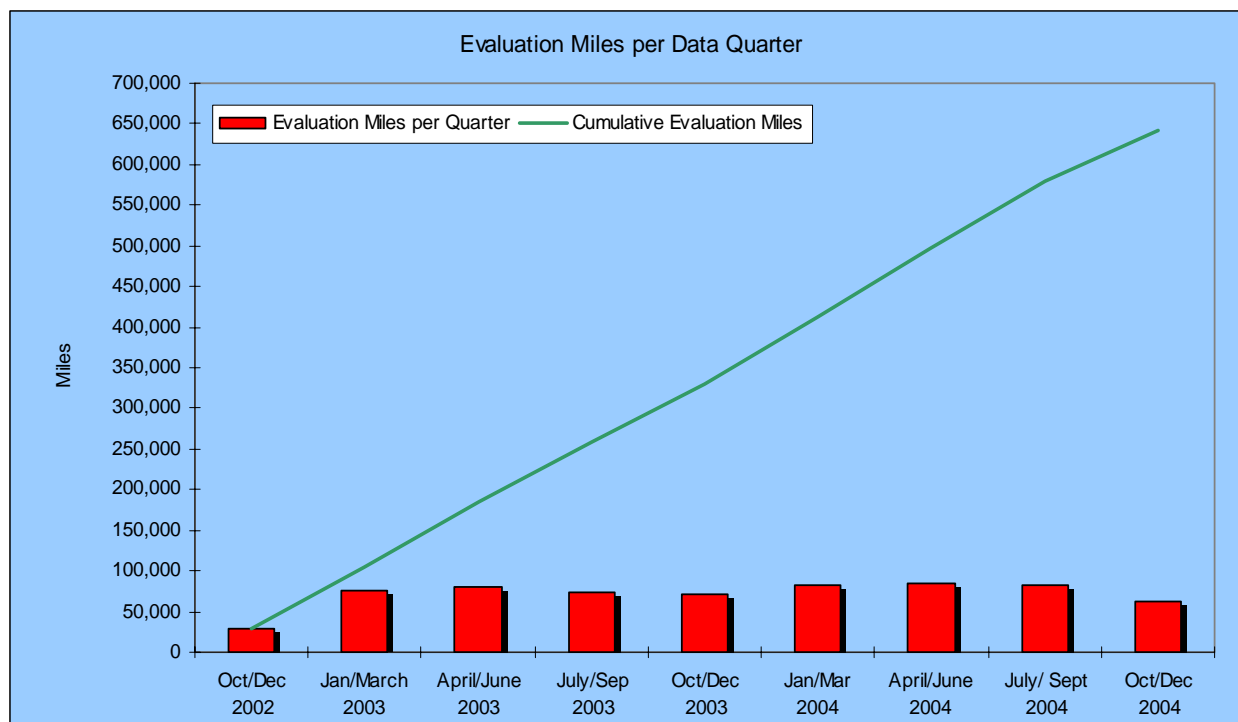
Figure 2. Quarterly and cumulative miles traveled by the test buses.

During this reporting quarter (October–December 2004), the 11 diesel-powered buses traveled 62,188 miles. Fewer miles (19,935) were travel this quarter (compared to the July-September quarter) mainly due to holidays and the annual INL work curtailment in December. Figure 2 shows the quarterly and cumulative evaluation miles. Table 2 details the mileage status of the eleven test buses. Figure 3 shows the total evaluation miles per bus by evaluation quarter. And Figure 4 shows the mileage per oil change history by bus.

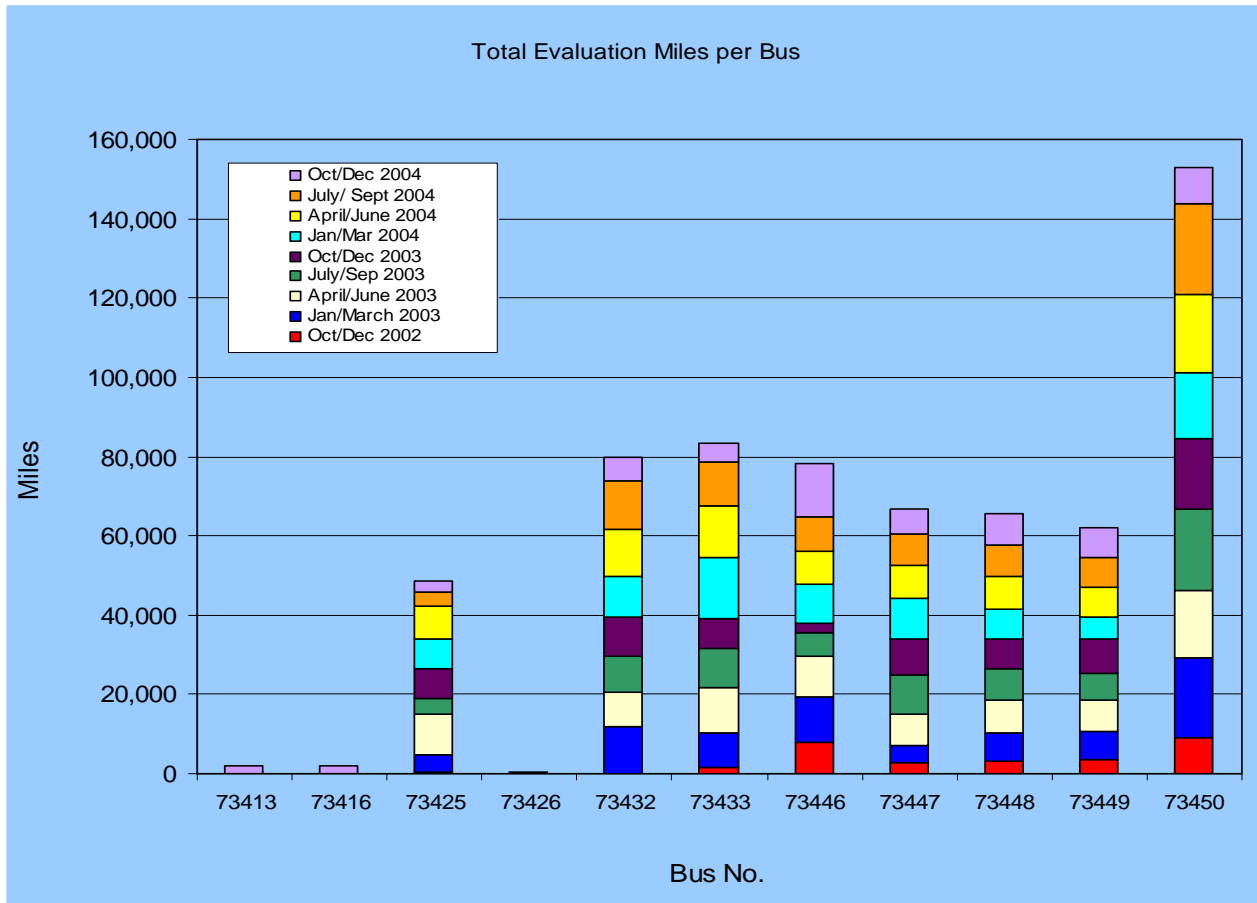
Figure 3. Total evaluation miles by bus for the October–December 2004 quarter.

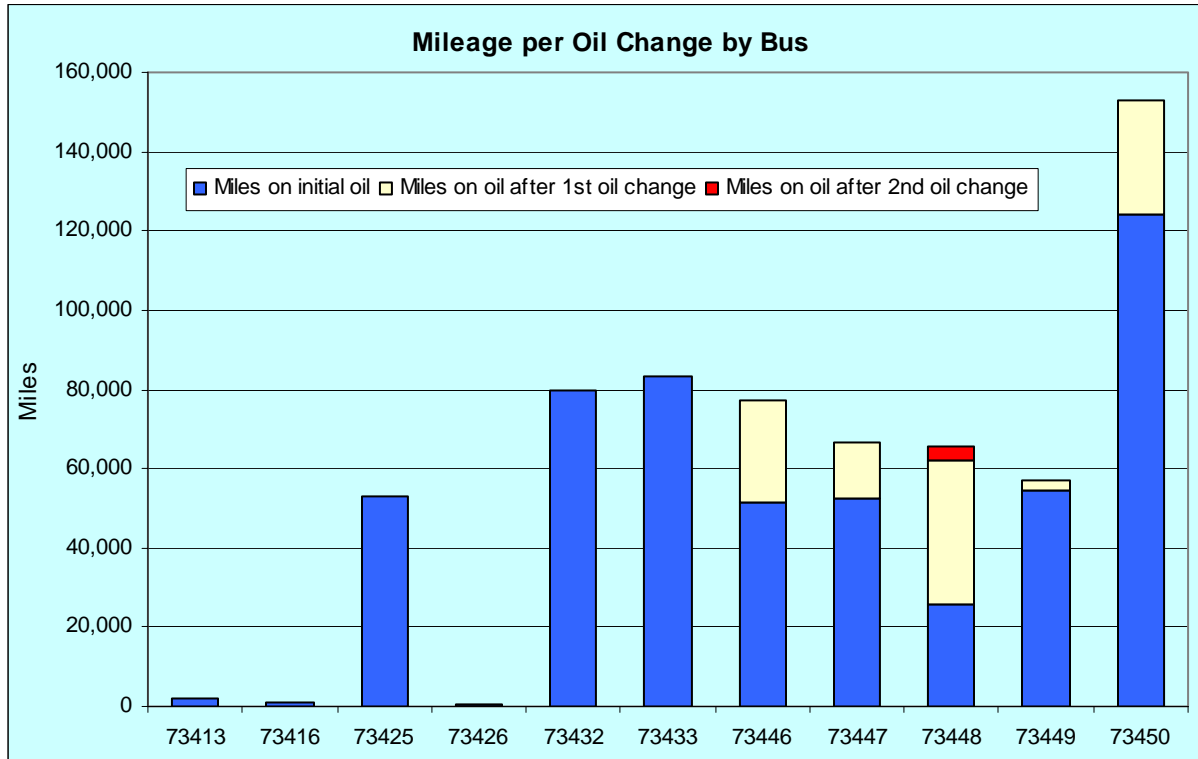
Figure 4. Test miles per oil change by individual bus. The oil on bus 73448 was inadvertently first changed in error on 9/16/03.

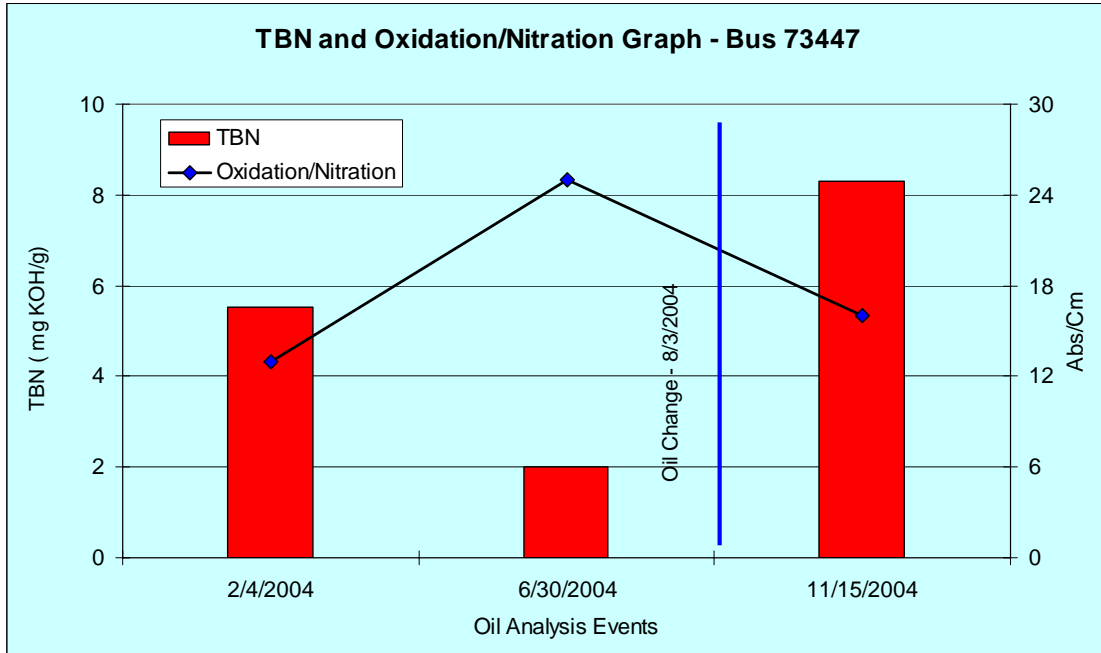
Figure 5. Inverse relationship between TBN and oxidation/nitration levels for three oil testing reports on bus 73447.

The total base number indicates the acid reducing value of the oil, whereas oxidation and nitration levels are a measure of the chemical processes of aging in the oil resulting from such engine conditions as high temperature, catalysts present in the oil (water, air, and wear metals), and other contaminants present (fuels and process chemicals). As oxidation and nitration values increase, other oil quality elements, such as TBN and viscosity, tend to degrade and to reduce lubricant life. When the TBN is high, the oxidation/nitration numbers are normally low. Bus 73447 in Figure 5 is an example of this. Whereas the bus 73448 oil analysis report for 6/30/04 shows a TBN of 2.0 and an average oxidation and nitration level of 25, three months after the oil was changed (11/15/04) the TBN value was above 8, and the oxidation/nitration level was about 15. Most of the bus oils show this same basic relationship, though some are more dramatic than others.

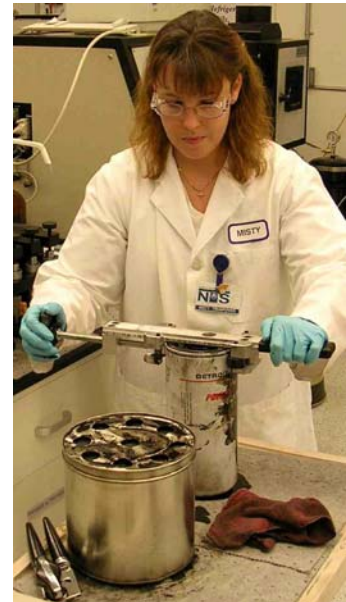
Figure 7. Removing the metal casing from the full-flow filter (using first cutter)

During filter preparation, the metal jackets were severed to facilitate removing the filter media, using two cutters (Figures 7 and 8). After the filter media is removed from the canisters, the media is dissected (Figure 9) to obtain representative samples of the filters—about one pound of media. The samples pieces are then placed into separate sample jars containing one liter of Chevron 100R Neutral Base Oil, and then sonicated (Figure 10) in a Branson Model 3500 Ultrasonic Cleaning Bath machine for 8 hours (per ASTM G131-96). This ultrasonic shaking separates the trapped particles from the filter media and places them into the neutral base oil.

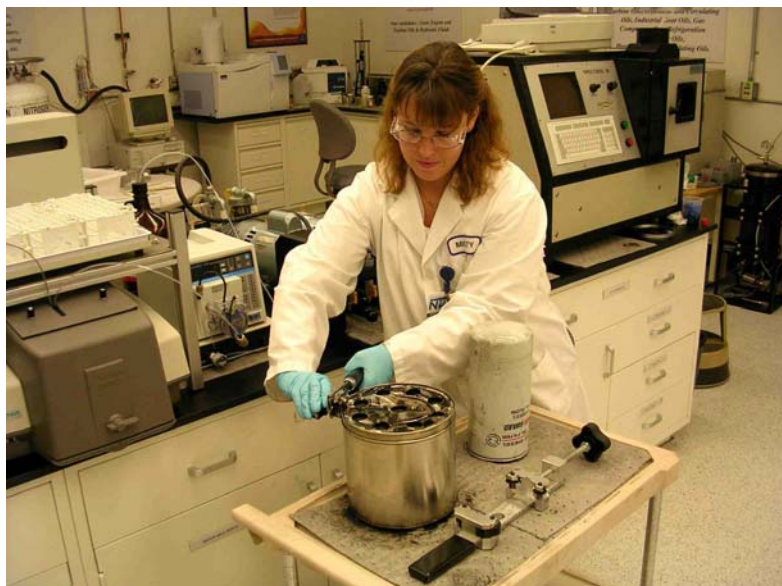
Figure 8. Removing the metal casing from the bypass filter (using second cutter).

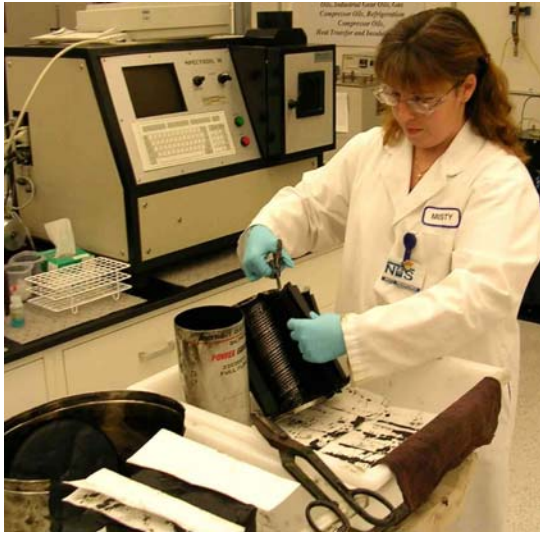
Figure 9. Filter media being dissected.

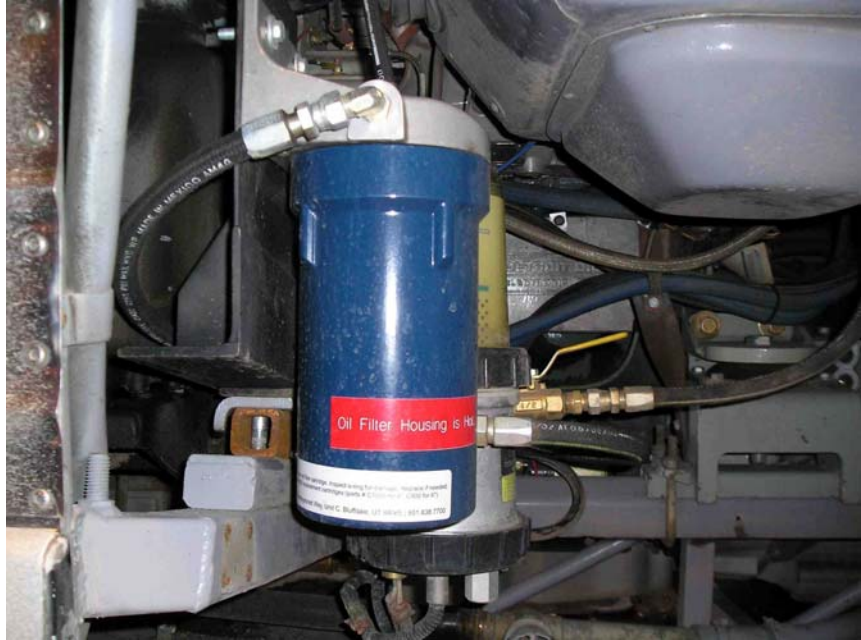
Figure 12. Close-up view of the angle bracket.

system parts and the existing diesel fuel filter. The mechanics unbolted the diesel fuel filter, installed the bracket, and then attached the diesel fuel filter to the bracket. Then they installed the filter housing on one side of the diesel fuel filter and the fluid evaporation unit on the other side. Figure 12 shows a close-up view of the bracket. Figure 13 shows a view of the installed system in the passenger-side engine compartment. Note that the large blue filter housing is on one side of the diesel fuel filter, and the small, barely visible, blue fluid evaporation unit is on the far side of the fuel filter.

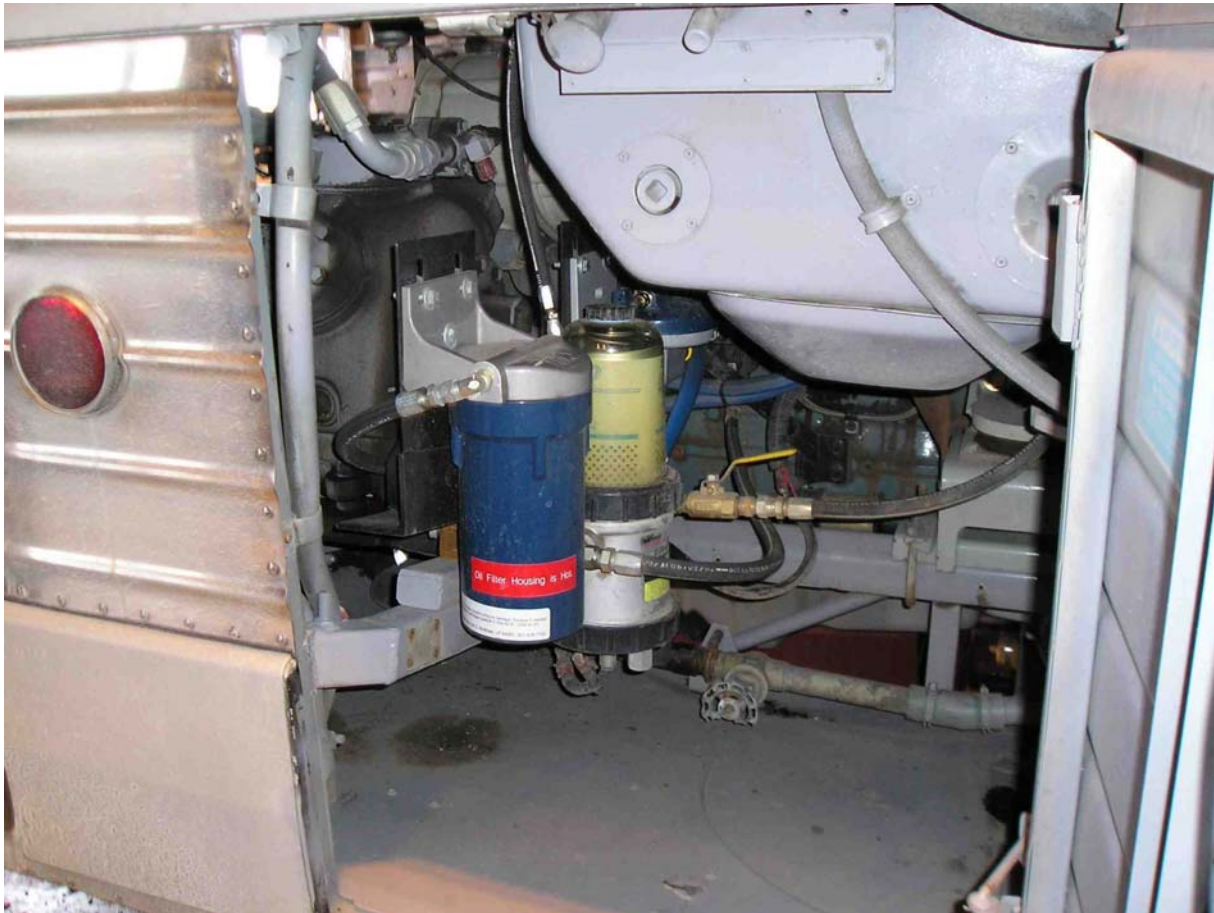
Figure 13. RGS bypass filter installation in the passenger side engine compartment.

Installation of these filter systems required some preinstallation engineering, because of the existing auxiliary equipment on the buses and space limitations in the engine compartment. Upon examination of the space available for the filter system, RGS personnel and INL mechanics selected appropriate locations for the RGS filter systems.

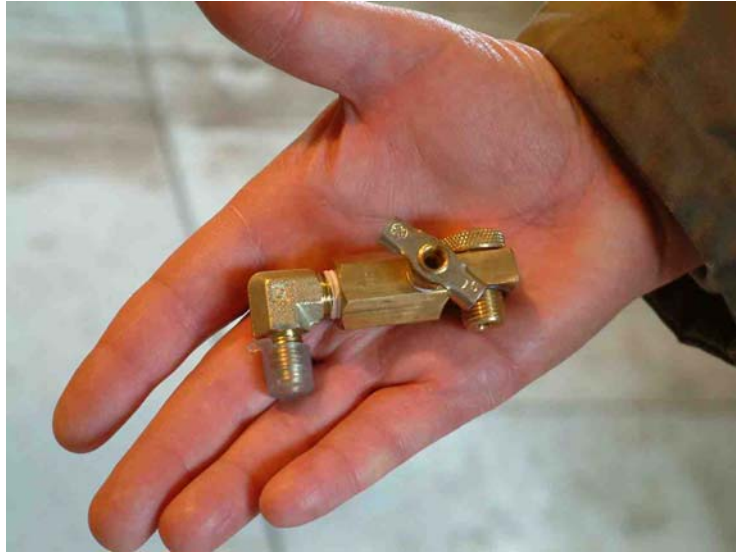
Figure 14. puraDYN orifice assembly with oil analysis sampling valve.

During this reporting quarter, the six light-duty Tahoe test vehicles traveled 39,514 miles, accumulating a total of 189,970 test miles. The Tahoe oils continued a trend of low TBN values with the Castrol 10W-30 oil. As a result of the low TBN values, INL consulted with puraDYN and they suggested increasing the oil metering orifice size to increase oil flow and bypass filtering to sustain higher TBN numbers. PuraDYN supplied six new meter jets and valve assemblies for installation (Figure 14). When the Tahoe's were originally outfitted with the bypass filter systems, the standard orifice (0.045 inch diameter) was used, but due to the cold weather in Idaho (-40°F is not unusual), this orifice allowed too much oil into the filter housing early in the mornings when the engines and oil were cold. The cold oil was too thick to flow through the filter media and would back up and overflow through a release valve in the filter housing. A valve with a cold weather orifice, 0.015625-inch (1/64-inch), was therefore installed, but it became apparent during the last year (low TBN values) that this valve was too restrictive to the flow. So puraDYN has provided a valve assembly with a 0.025-inch orifice to increase the bypass filter flow and the oil filtering. The new assemblies are being installed as the Tahoes are serviced. Details on the performance of the filters and oil in the Tahoes will be reported next quarter.

Five of the six Tahoe test vehicles have been retrofitted with new metering orifice assemblies having a larger orifice, 0.025, which provides a 63% increase in oil flow to the filter. This replacement is an attempt to sustain higher TBN values.
