Best Practices for Emergency Response to Incidents Involving Electric Vehicles Battery Hazards: A Report on Full-Scale Testing Results

Final Report

**Exponent, Inc.
17000 Science Drive, Suite 200
Bowie, MD 20715**

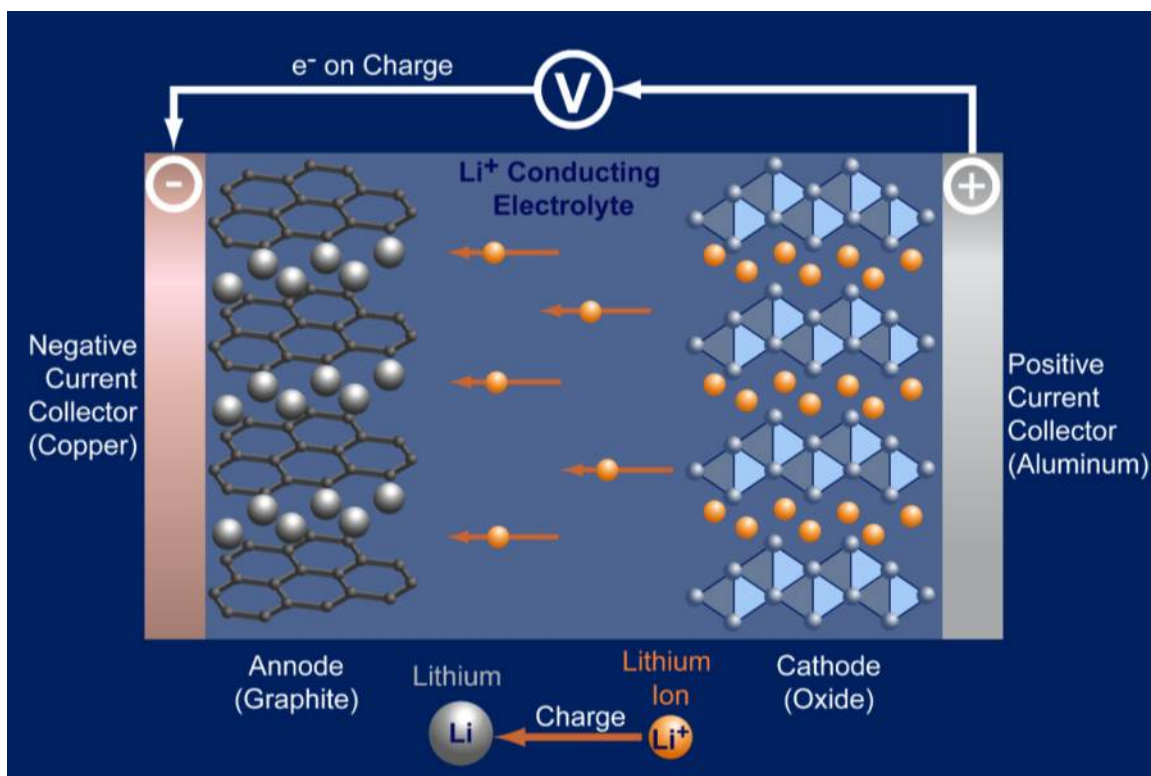
Figure 1 Li-ion cell operation, during charging lithium ions intercalate into the anode, the reverse occurs during discharge

In a Li-ion cell, alternating layers of anodes and cathodes are separated by a porous film (separator). An electrolyte composed of an organic solvent and dissolved lithium salt provides the media for Li-ion transport. A cell can be constructed by stacking alternating layers of electrodes (typical for high-rate capability prismatic cells), or by winding long strips of electrodes into a “jelly roll” configuration typical for cylindrical cells, as shown in Figure 2. Electrode stacks or rolls can be inserted into hard cases that are sealed with gaskets (most commercial cylindrical cells), as shown in Figure 3, laser-welded hard cases, as shown in Figure 4, or enclosed in foil pouches with heat-sealed seams (commonly referred to as Li-ion polymer cells⁷), as shown in Figure 5. A variety of safety mechanisms might also be included in the

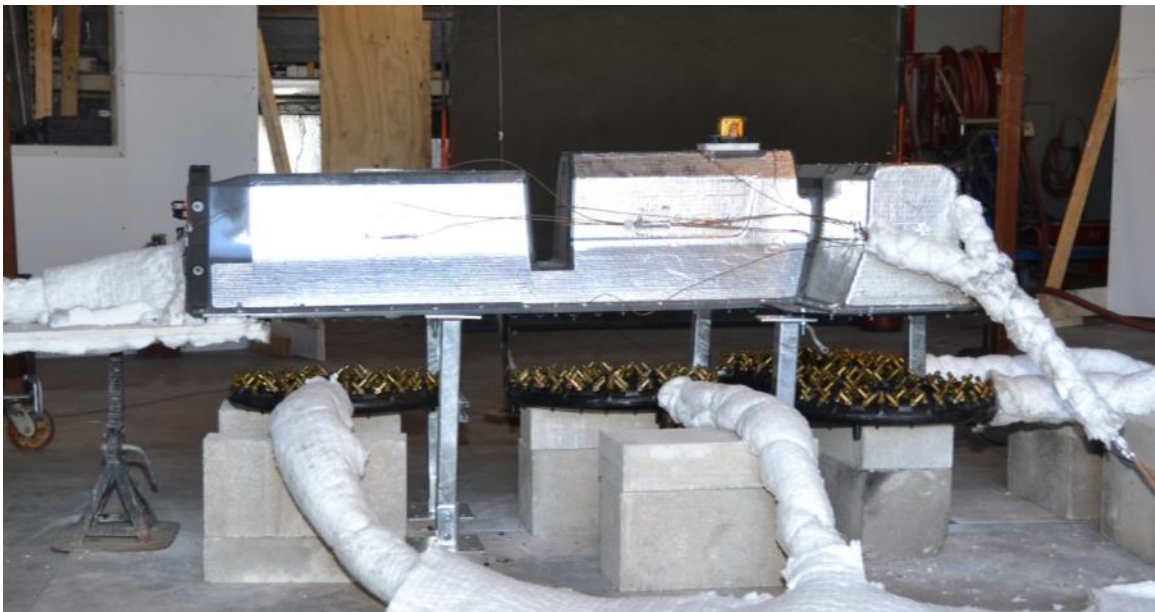
Figure 11 Battery B configuration and burner locations for HRR testing

Battery B was centered under a 20 foot by 20 foot hood supported by five stainless steel legs, as shown in Figure 11 and Figure 12. The leg supports held the battery in place, twenty inches above the ground to provide a viewing angle to the bottom of the battery during testing.

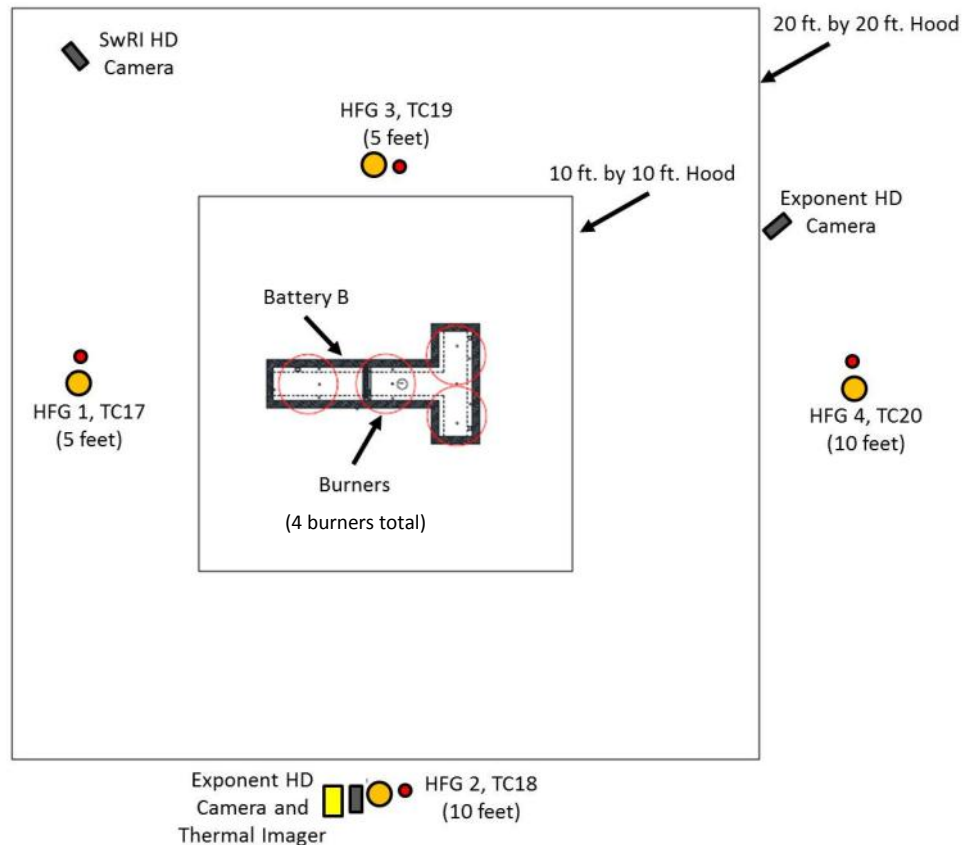
Figure 12 Layout and arrangement of the HRR testing perimeter instrumentation

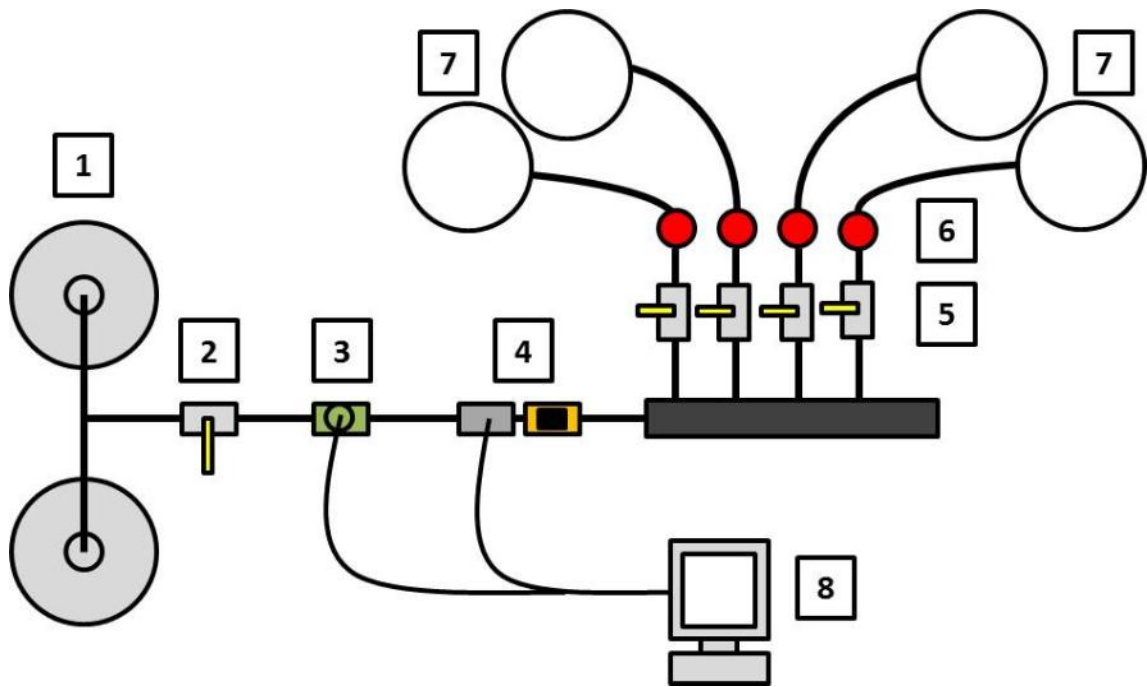
Figure 13 Layout of burner assembly

From the outlet of the mass flow controller, LP-gas continued via 1-inch stainless steel piping to a four-outlet manifold, allowing for simultaneous operation of up to four (4) burners. From each of the manifold outlets, a 1/4-inch manual isolation valve and a second stage regulator are instrumented, respectively. A 1/4-inch flexible stainless steel braided hose 40 feet in length was used to connect the outlet of the second stage regulator to a circular, 19-inch diameter gas burner containing eighty-eight (88) 0.30-inch diameter nozzles. Exponent utilized four burners positioned under the span of the T-shaped battery to provide an even heat source to the entire battery pack, as shown in Figure 15 and Figure 16. The burners were placed six inches under the battery, as measured from the top of the nozzle tip to the bottom of the battery frame to allow for optimal flame development from the burners.

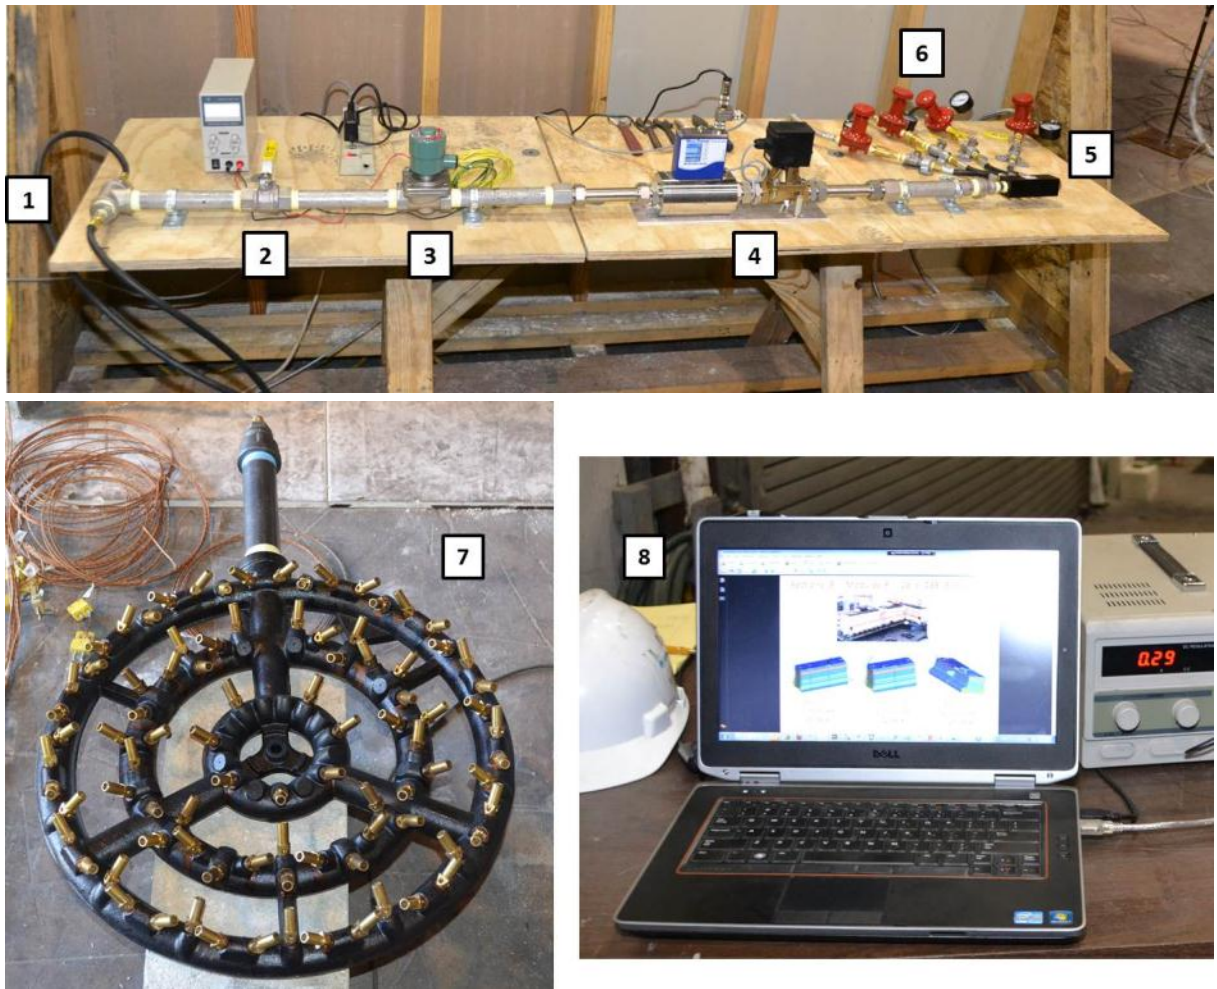
Figure 14 Burner assembly (top); single burner (bottom left); and DAQ (bottom right)

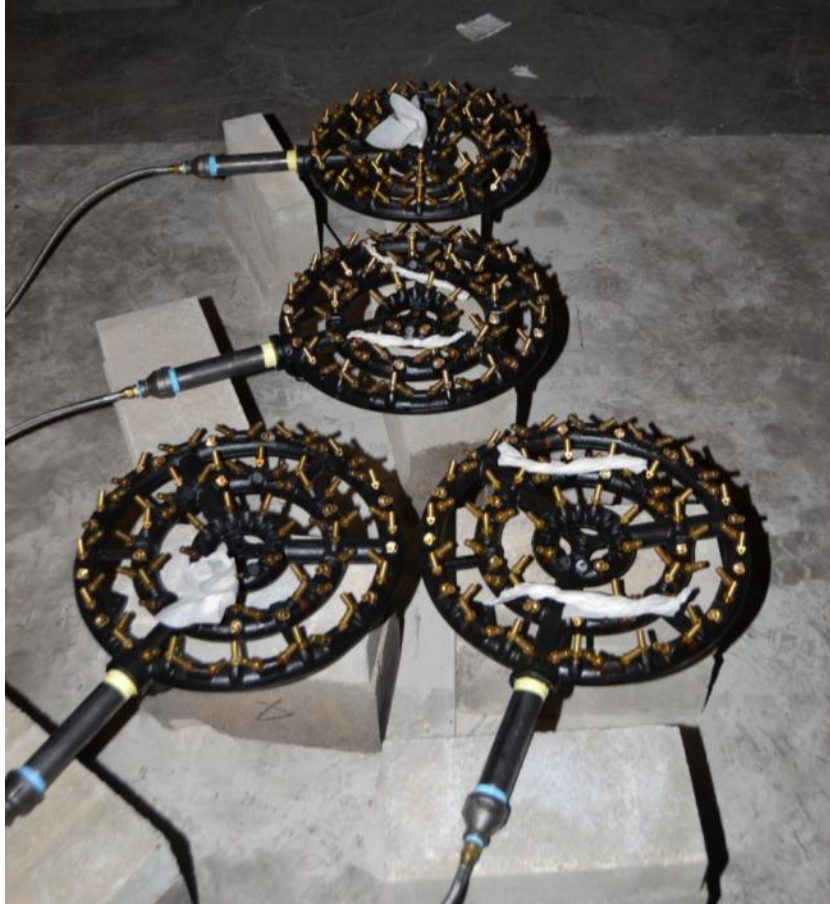
Figure 15 T-shaped burner arrangement comprised of four burners

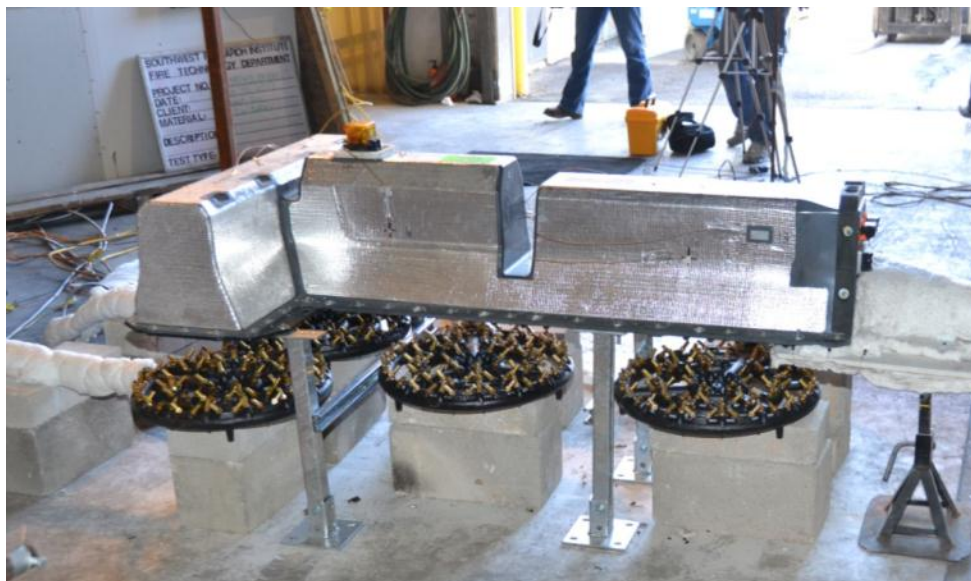
Figure 16 Four burners positioned under Battery B

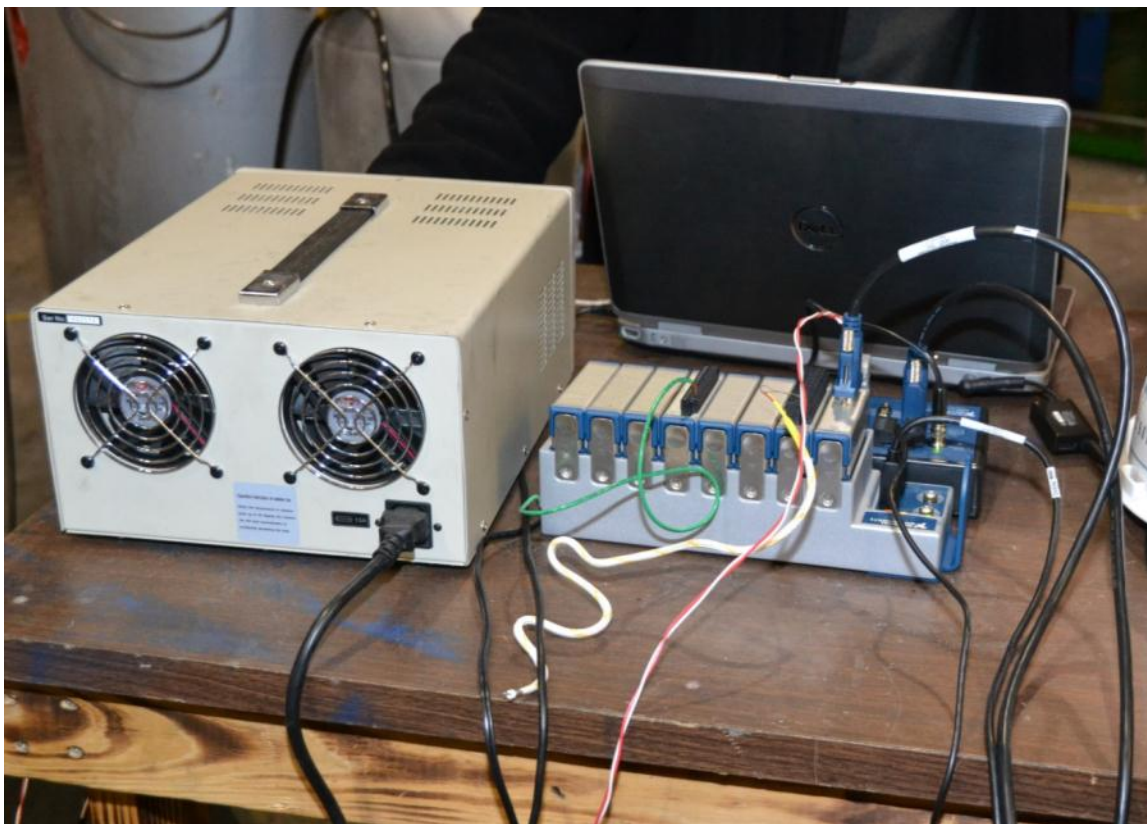
Figure 20 NI 9862 CAN bus module and 7-port NI CAN breakout box

frames to and from the battery. The NI 9862 is a single-port high-speed CAN bus module and the 7-port NI CAN breakout box provided a means to power the CAN port and to set the termination resistance. The NI 9862 bus module and CAN breakout box are shown in Figure 20. The NI 9862 was connected to the breakout box using an NI CAN high-speed cable. The breakout box was in turn connected to the battery using a custom interface cable provided by the manufacturer. In addition, the manufacturer provided the necessary binary codes to Exponent to use in its custom Lab VIEW program so that communication could occur. This cable connected directly to the battery, as shown in Figure 21. To protect these connection points and the cables, a calcium silicate board assembly was installed just below the connection points to shield the area from direct flame impingement by the burners below. In addition, Kaowool insulation ceramic fiber blankets were wrapped around these connection points and cables to insulate them from heat, as shown in Figure 22.

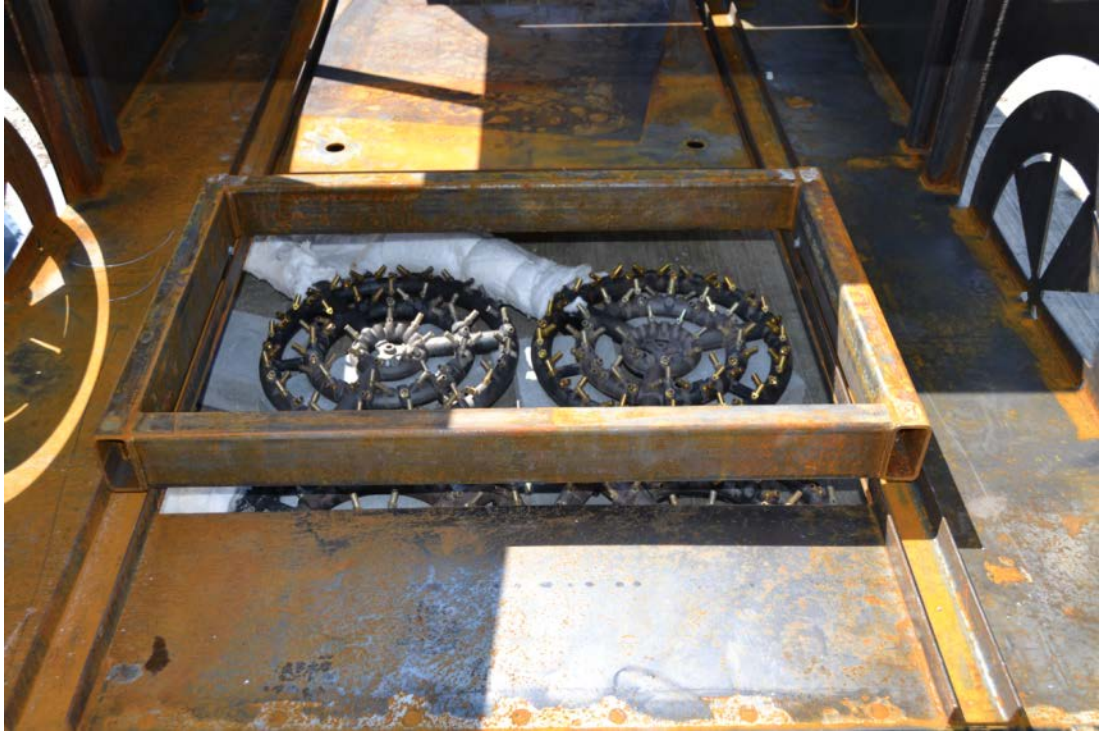
Figure 25 Carriage installed inside the VFT positioned above the four burners located in the rear test position

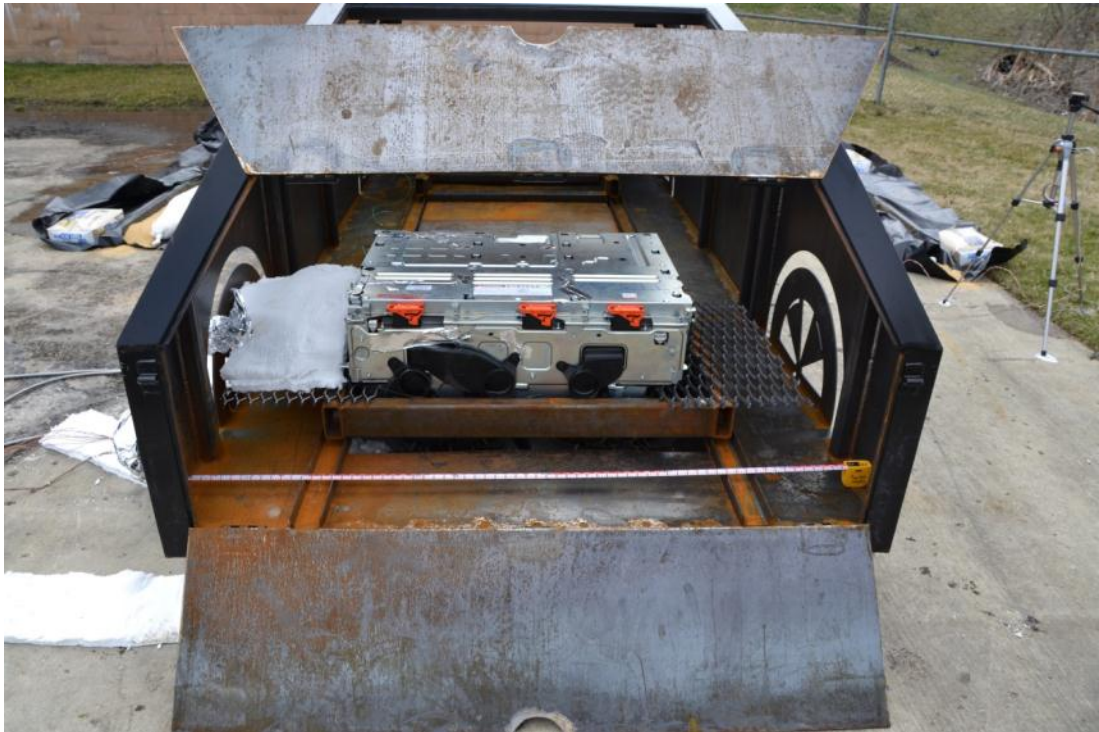
Figure 26 Battery A positioned on the carriage above the burners and inside the VFT

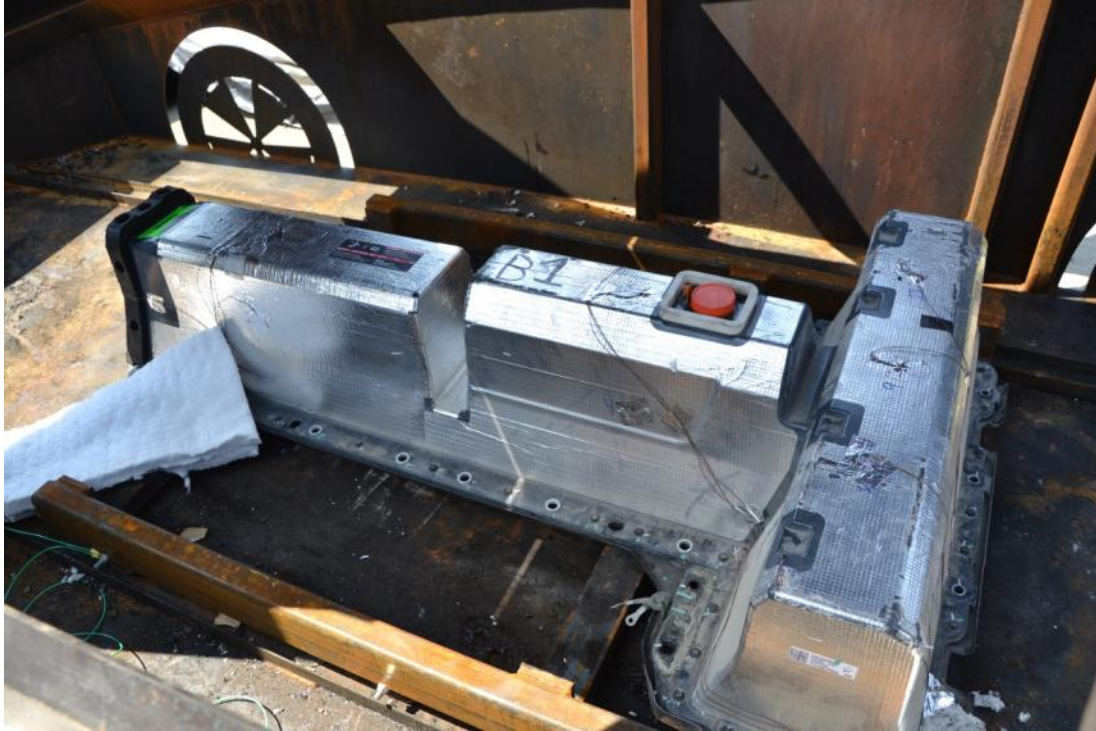
Figure 27 Battery B positioned on the carriage above the burners inside the VFT; burners located in the center test position

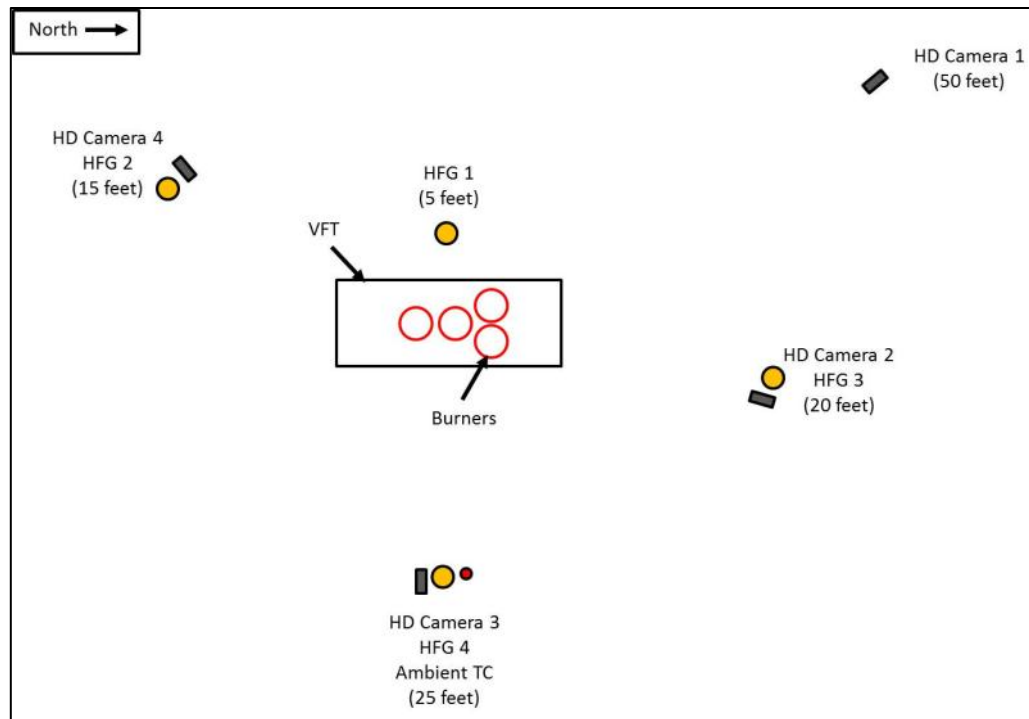
Figure 28 Layout and arrangement of the suppression testing perimeter instrumentation

The VFT was placed on a concrete burn pad at MFRI, as shown in Figure 28. The burners slid under the VFT and into position depending on the battery type and had direct access to the bottom of the batteries through the holes cut out in the VFT floor pan. For Battery A, the four burners were centered six inches under the rectangular battery, as shown in Figure 25 and Figure 26. For the first two tests, Tests A1 and A2, the battery was installed alone within the VFT, as shown previously in Figure 26. For test A3, typical interior finishes/upholstery, including car seats, a dashboard, and a carpet layer above the battery (used to separate the battery from the cargo compartment) were also installed within the VFT, as shown in Figure 29 through Figure 33. The car interiors were procured from vehicles that were of a similar size as the VFT. These additional vehicle interior finishes were installed to better simulate the fuel load of a typical vehicle.

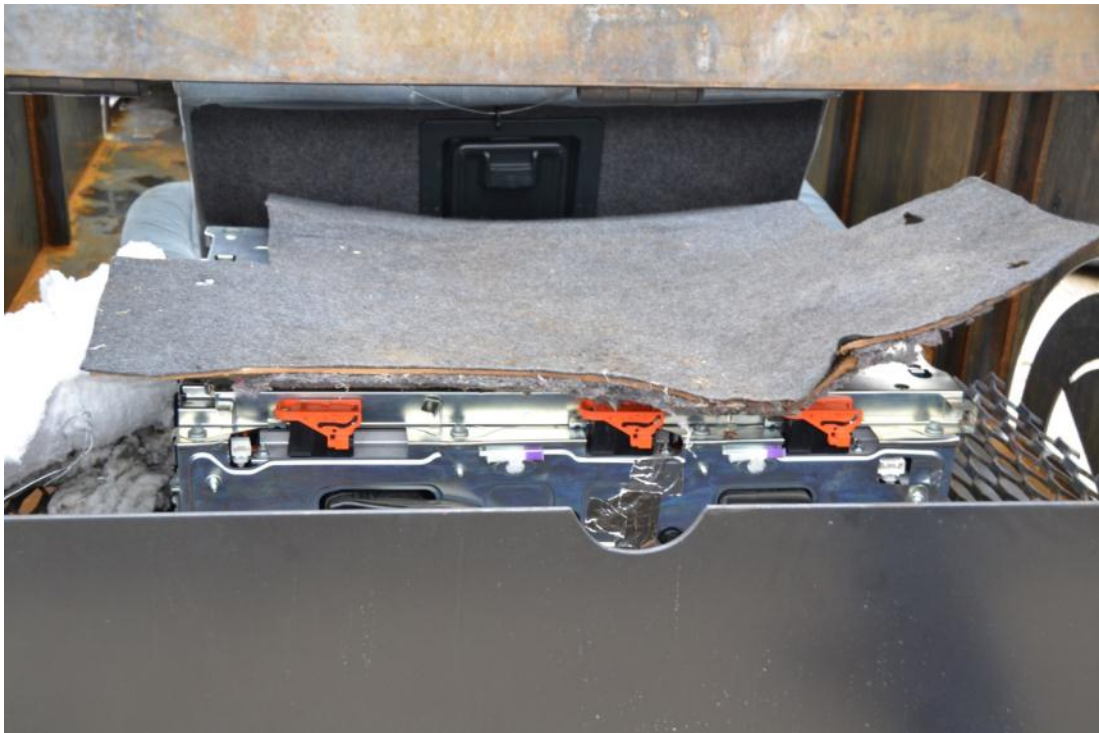
Figure 33 Carpet installed on top of the battery for Test A3

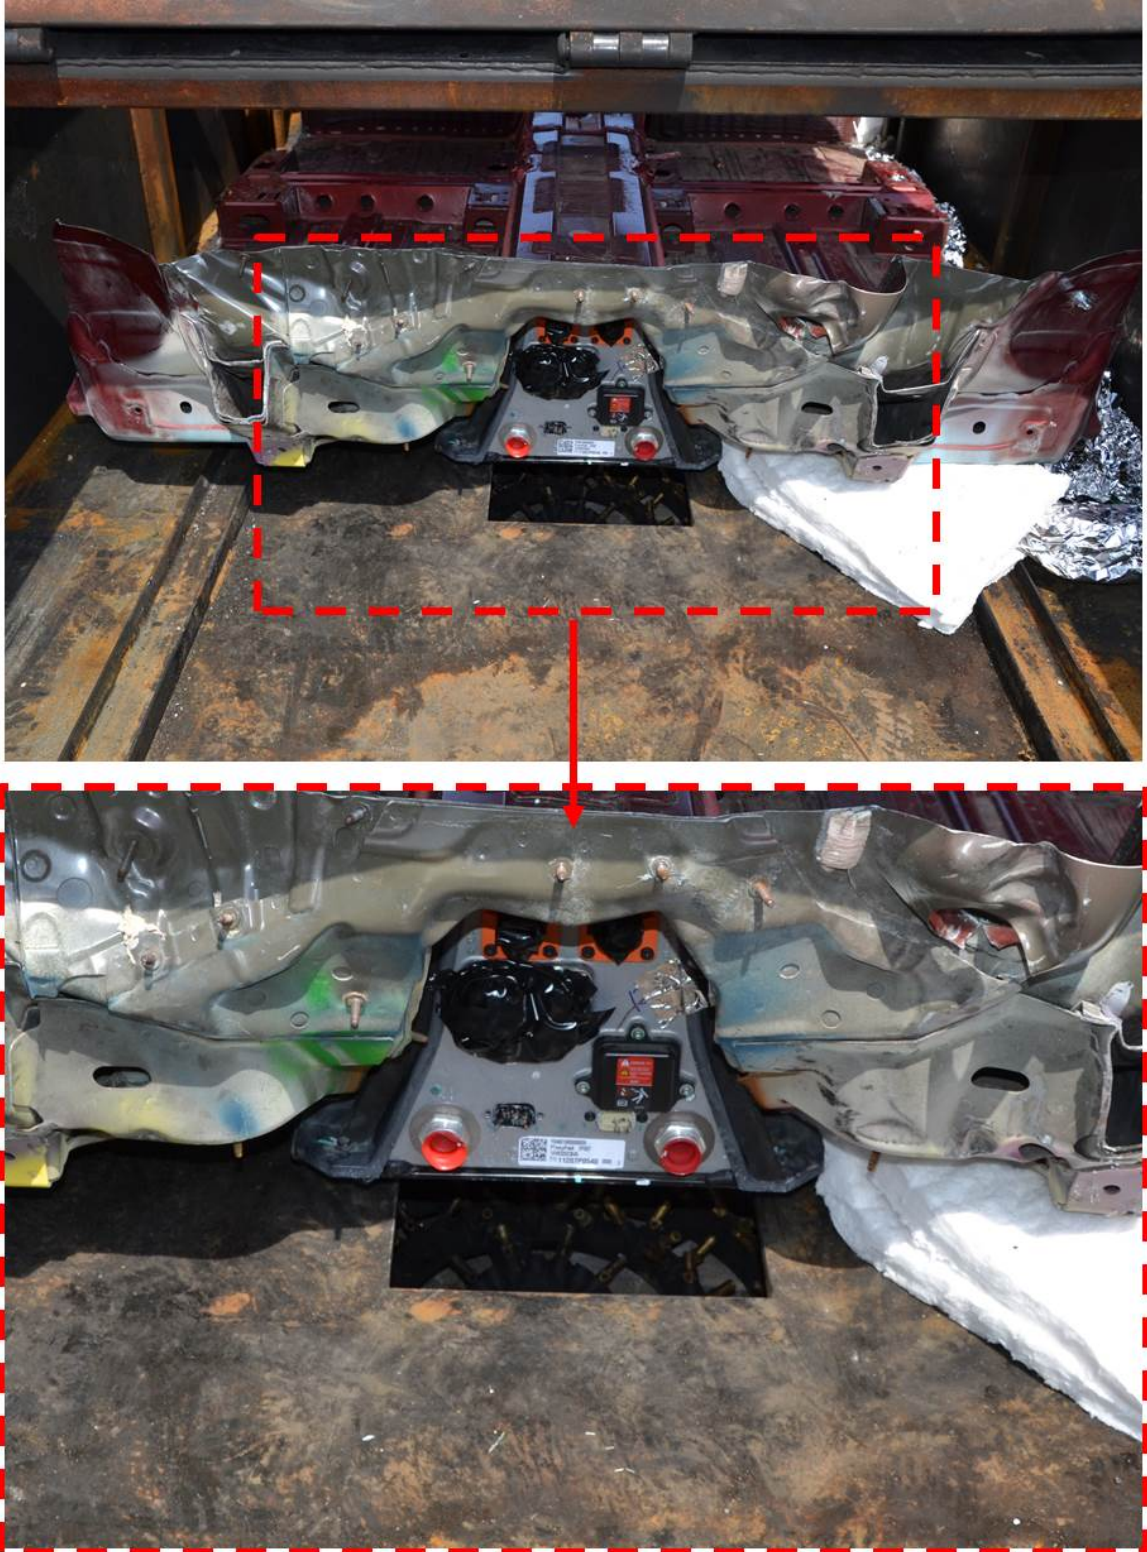
Figure 46 Connection points to Battery B once installed inside the VFT (before protection)

During the Battery B tests, Exponent collected internal battery temperatures and individual cell voltages from the battery's own sensors. Exponent was not provided with the necessary supporting information to communicate with the A series batteries. These measurements were collected for as long as the connection between the battery and the DAQ system would allow (i.e., that is until fire exposure conditions compromised the communication paths). To collect this data, Exponent communicated directly with the battery using the same software programs, cables, equipment, sensors, and connection points to the battery described in Section 5.1.6. Prior to the suppression tests however, the battery was installed within the VFT, which required a slightly modified protection scheme for the battery's connection points. To protect these connection points, a modified calcium silicate board structure was erected around the front end of the battery once it was positioned within the VFT, as shown in Figure 46 and Figure 47. This structure shielded the connection area from direct flame impingement by the burners below, as well as any flames licking around the bottom edge and sides of the battery. In addition, Kaowool was inserted into the structure to insulate the connection points further and wrapped around the cables running to the battery from the DAQ system.

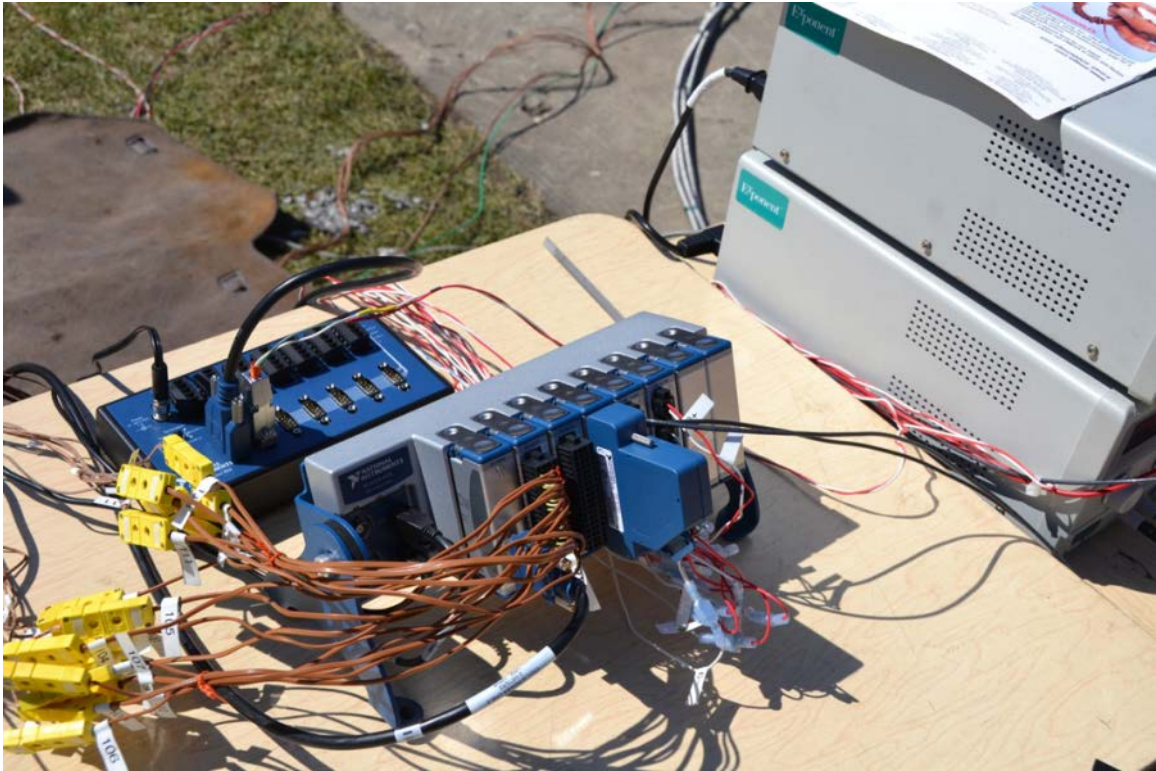
Figure 48 NI 9213 TC module and NI 9207 voltage module (for HFGs) plugged into the NI cDAQ 9178 data acquisition chassis

The electrical measurements were performed at two different sampling rates by two data acquisition modules. The chassis voltage and current were monitored at a sampling rate of 1 Hz by the NI 9213 module described above. The nozzle voltage and current were continuously sampled at a rate of 2000 Hz by an NI 9239 module, a high-speed 4-channel analog input module with 24 bits of resolution, channel-to-channel isolation and anti-aliasing circuitry.

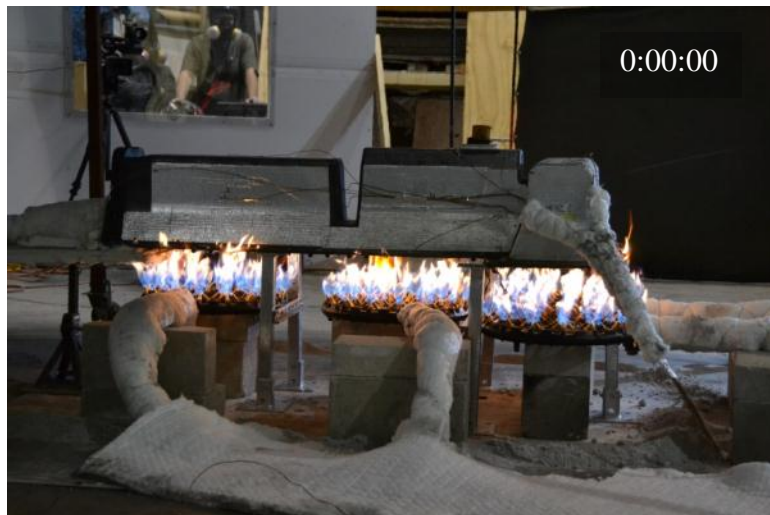
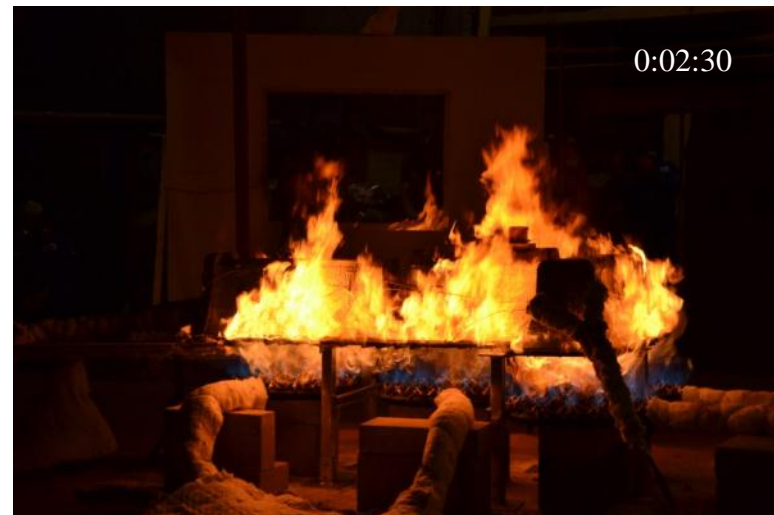
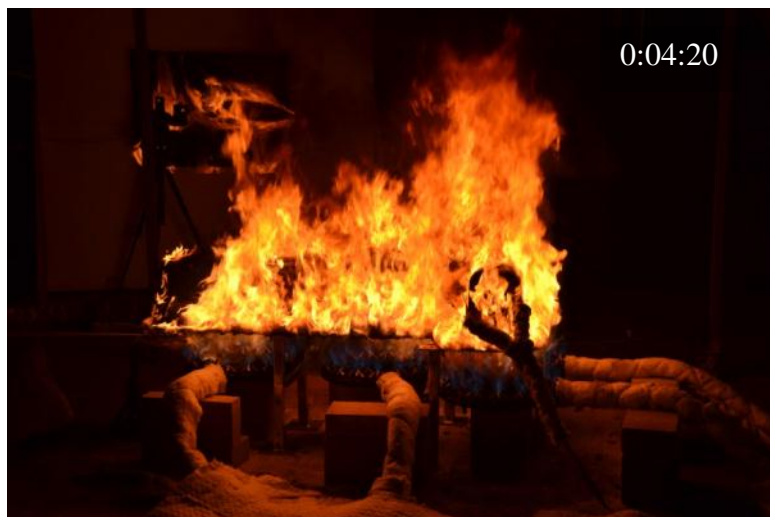
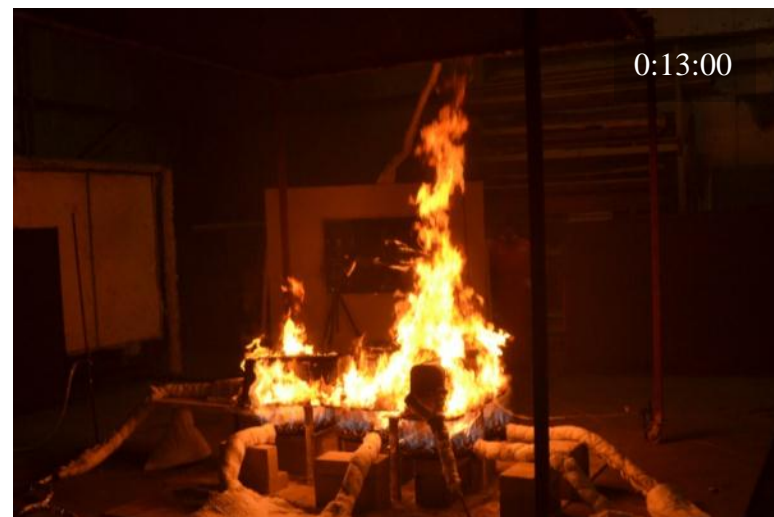
Figure 50 0 minutes (top left), 2:30 minutes (top right), 4:20 minutes (bottom left), 13 minutes (bottom right)

0:17:42	Visible sparks coming from interior of NW vent hole
0:20:36	Propane burners turned off
0:23:00 – 0:25:00	Fire size noticeably begins to weaken
0:47:10	Flames only observed shooting out of the northwest battery vent, top fuse and CAN bus connection ports

1:03:00	Loud pop heard and the fire at the top fuse goes out
1:20:00	Loud popping heard
1:30:00	Loud popping heard
1:34:00	Last flame goes out, battery continues to smoke

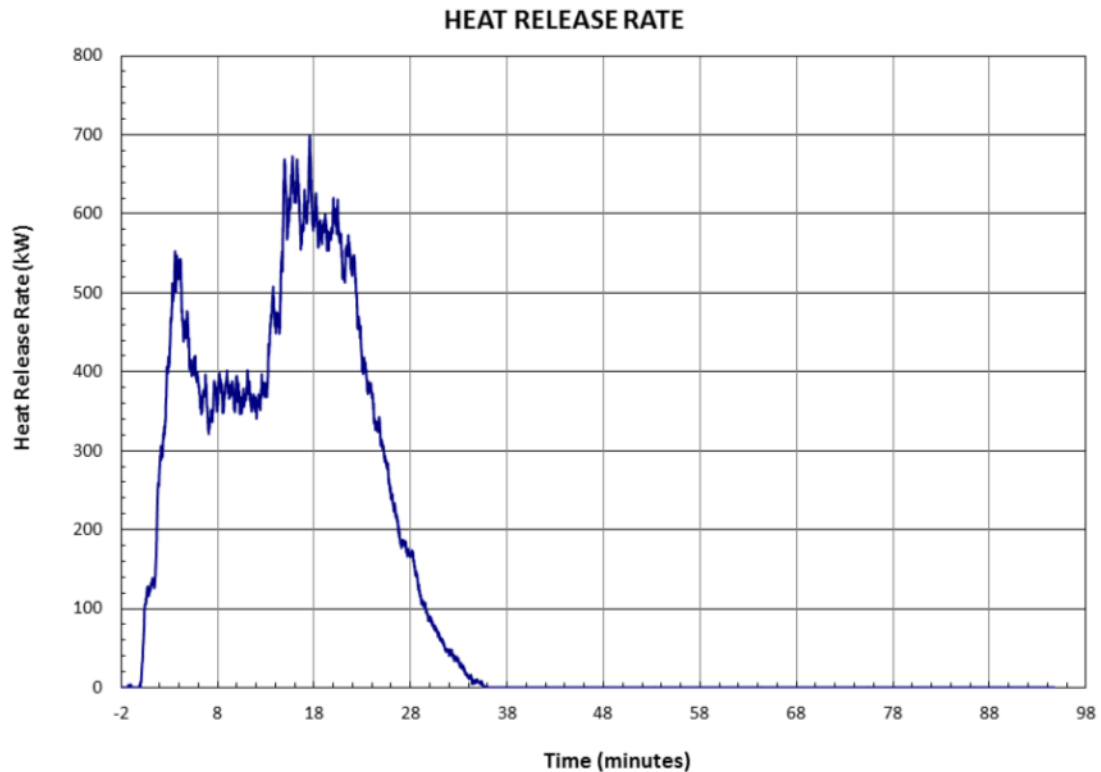
Figure 53 HRR as a function of time

In addition to the maximum HRR reported in Table 7, the average HRR over the entire 90 minute test and the total heat release were calculated to be 128 kW was 720 MJ, respectively.

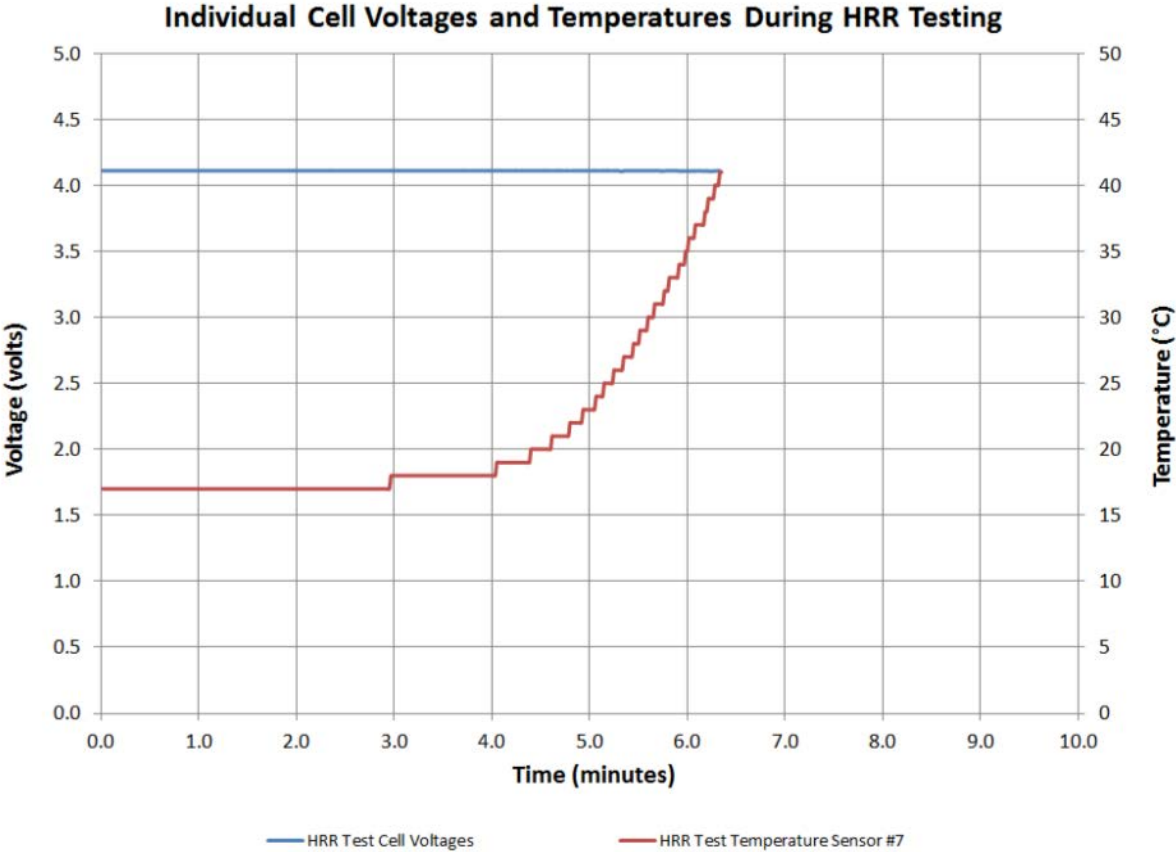
Figure 54 Internal cell voltages and temperatures (Sensor #7) during HRR Testing

voltage was checked. The cables were not short-circuited, further indicating that the communication problem was internal to the battery. The likely failure mode was an internal wire transmitting power to the CAN bus developed a short circuit, terminating the ability of the battery to communicate via the CAN bus.

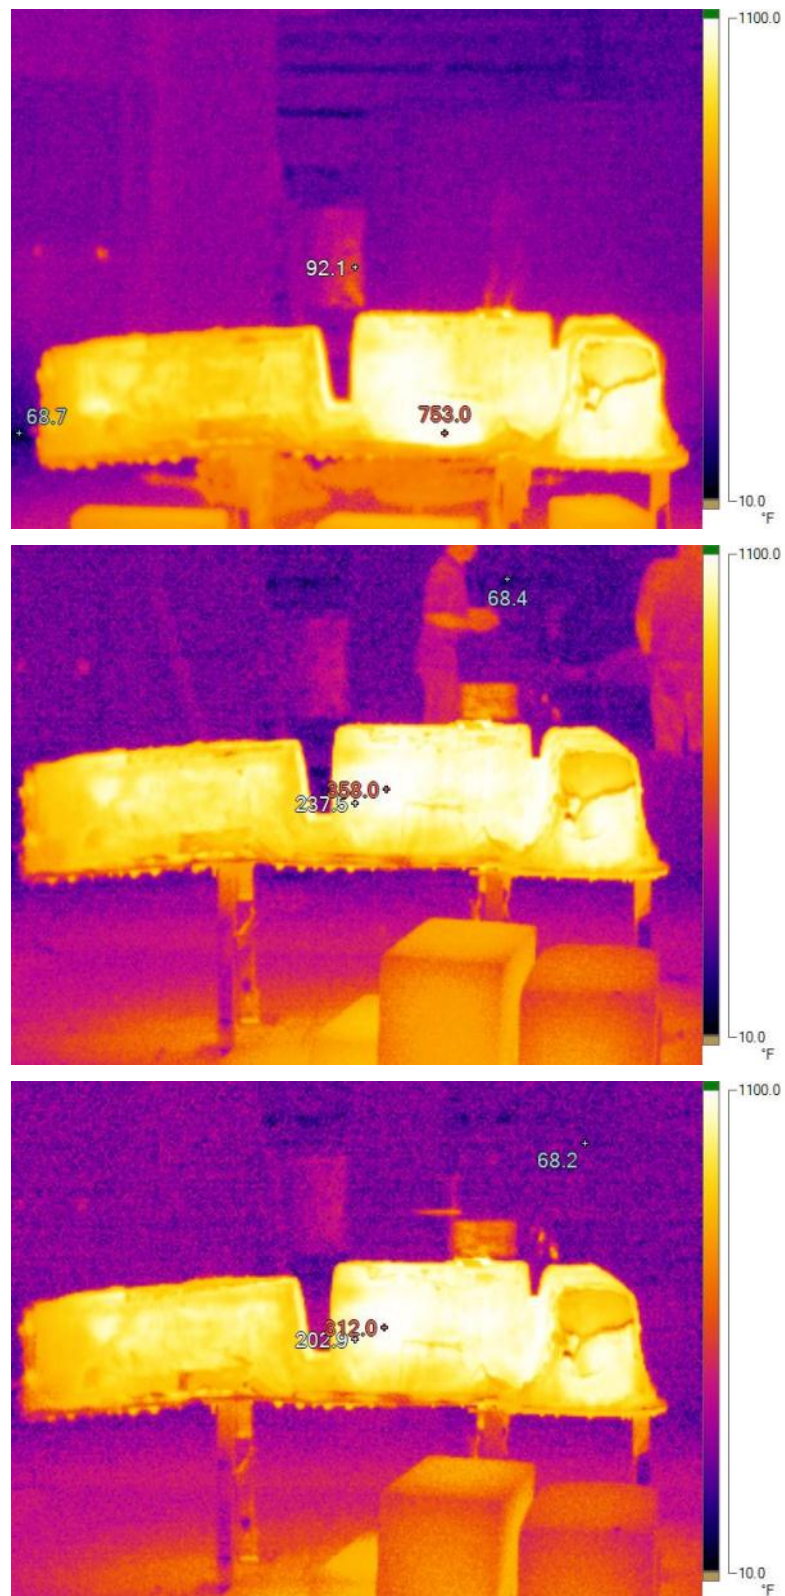
Figure 56 Thermal image 0 hours (top); 2 hours (middle); and 3 hours (bottom) after visible flaming ceased

After approximately 1:34 minutes of elapsed time, all visible flaming ceased. Thermal images were recorded as the battery cooled. Thermal images were captured for an additional three hours and 15 minutes. When visible flaming ceased at 1:34, the observed exterior maximum temperatures were approximately 753 °F. Two hours later, maximum observed temperatures were approximately 358 °F. Three hours after all visible flaming ceased, maximum observed temperatures were approximately 312 °F, as shown in Figure 56.

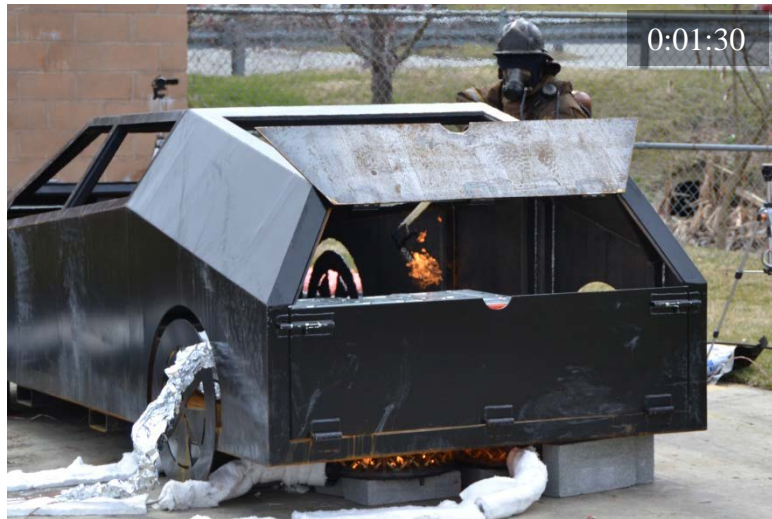
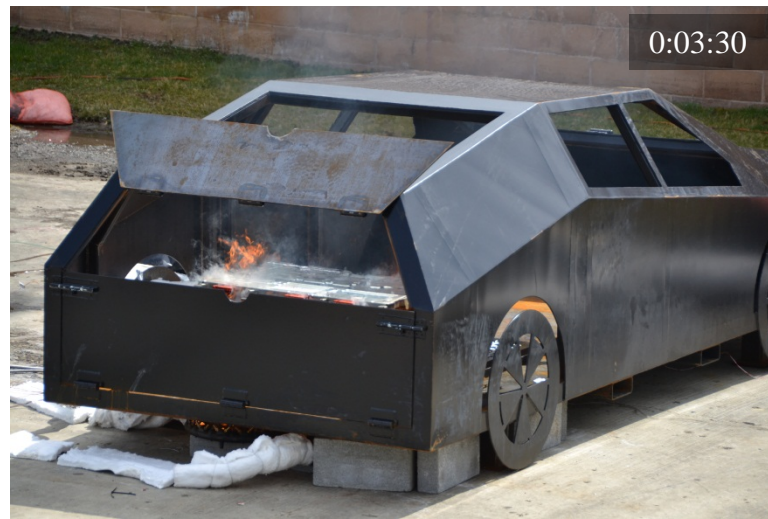
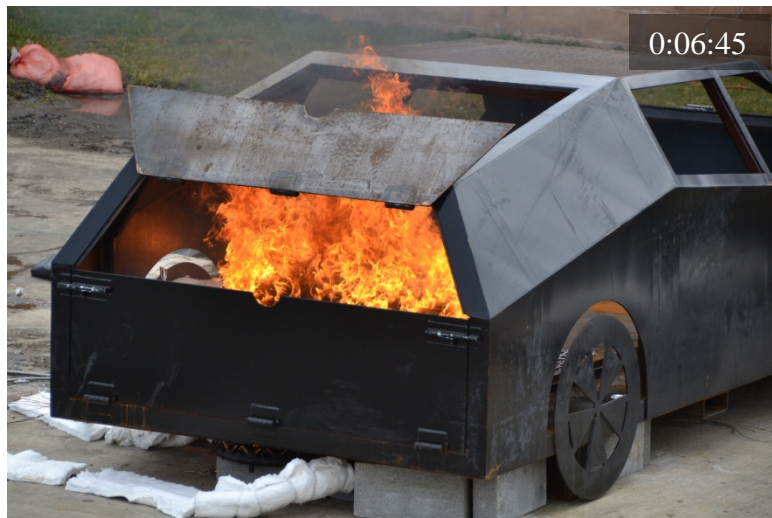
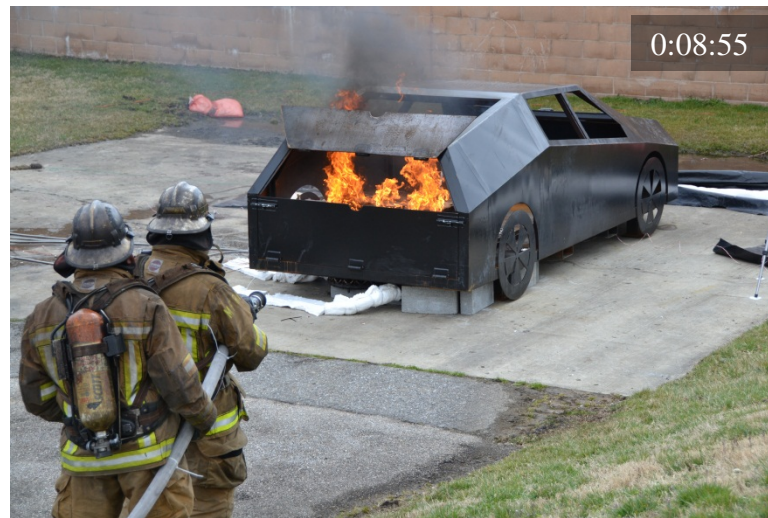
Figure 57 Test A1: ignition (top left); off gassing (top right); fully involved (bottom left); burners off (bottom right)
