Best Practices for Emergency Response to Incidents Involving Electric Vehicles Battery Hazards: A Report on Full-Scale Testing Results

Final Report

**Exponent, Inc.
17000 Science Drive, Suite 200
Bowie, MD 20715**

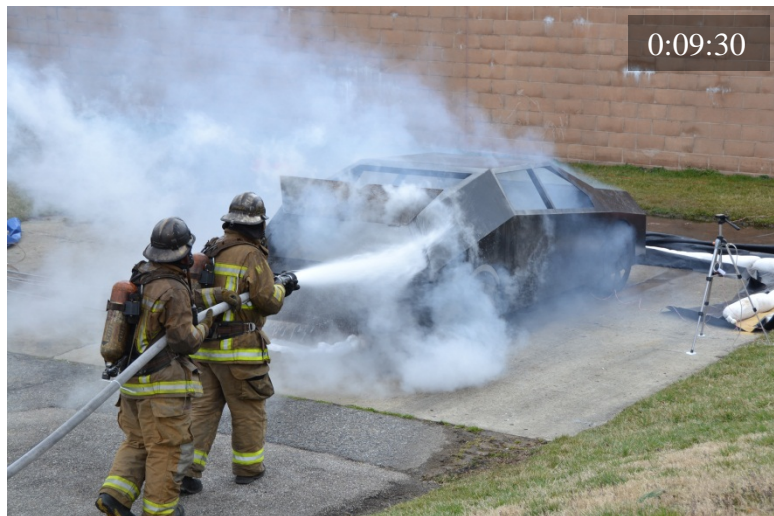
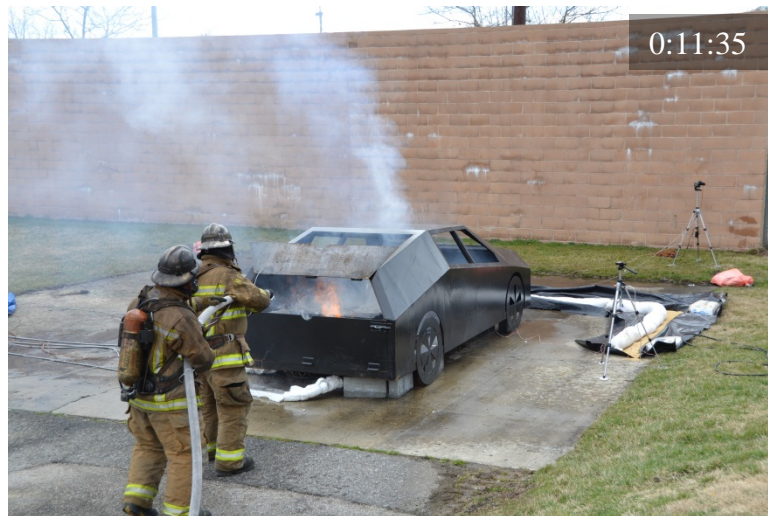
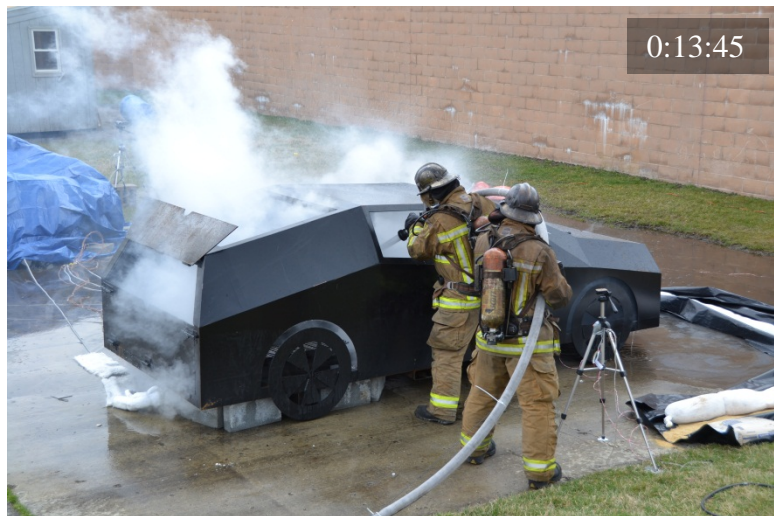
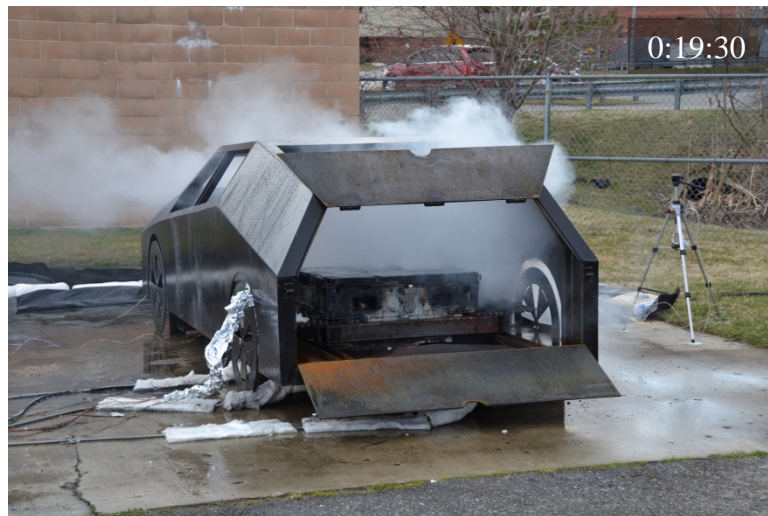
Figure 58 Test A1: Suppression starts (top left); reignition and suppression (top right, bottom left); post suppression (bottom right)

Time	Event
0:11:45	Battery fire reignited and suppressed
0:12:15 – 0:12:23	Electrical sparks observed
0:13:00	Pops
0:14:30	Start water application up into rear ports of battery
0:14:43	Sparks observed
0:18:26 – 0:19:04	Off gassing / white smoke
0:23:18	Pops
0:35:20	Off gassing / white smoke
1:00:00	Data acquisition off

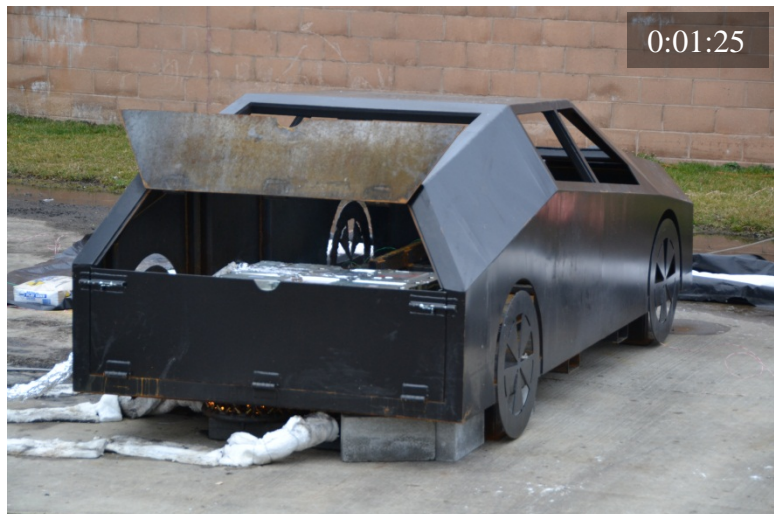
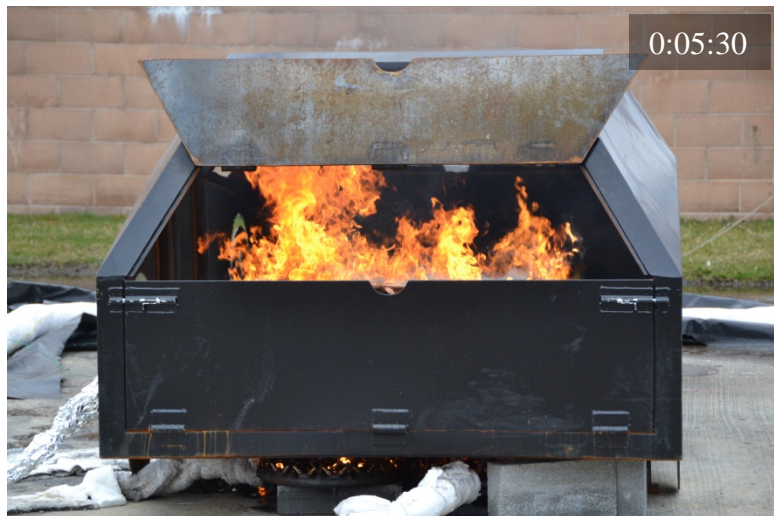
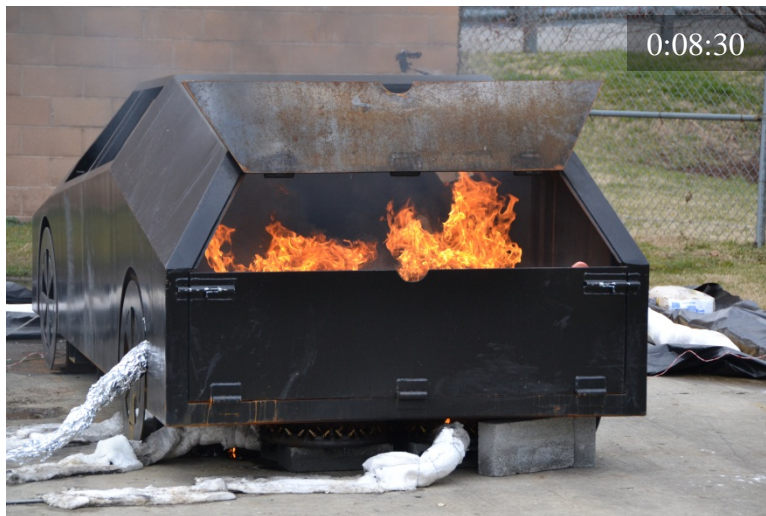
Figure 62 Test A2: ignition (top left); off gassing (top right); fully involved (bottom left); burners off (bottom right)

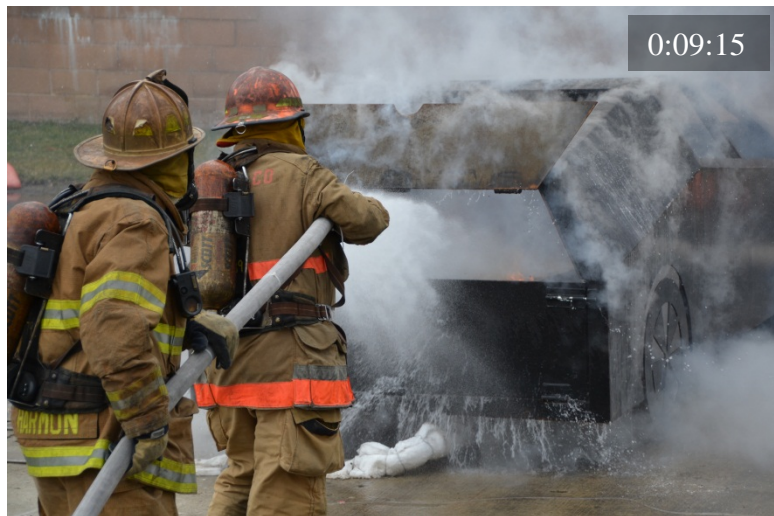
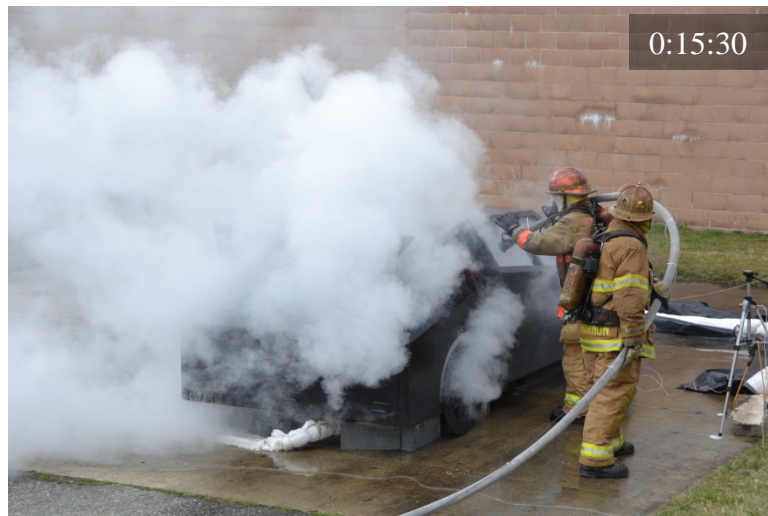
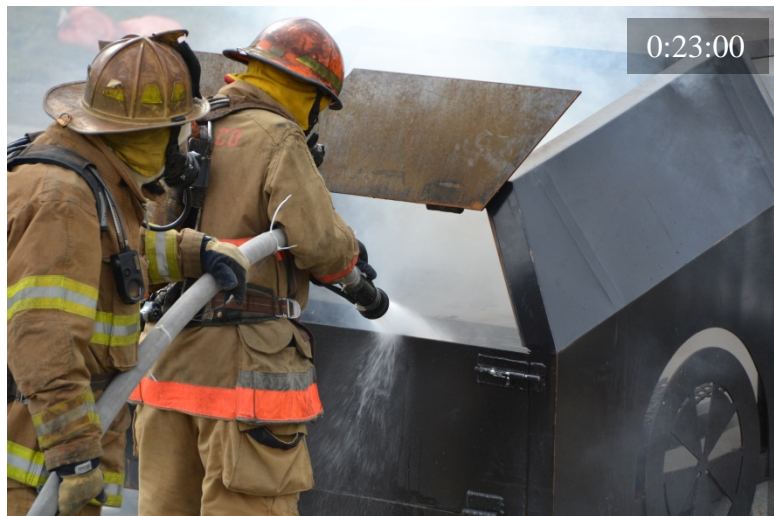
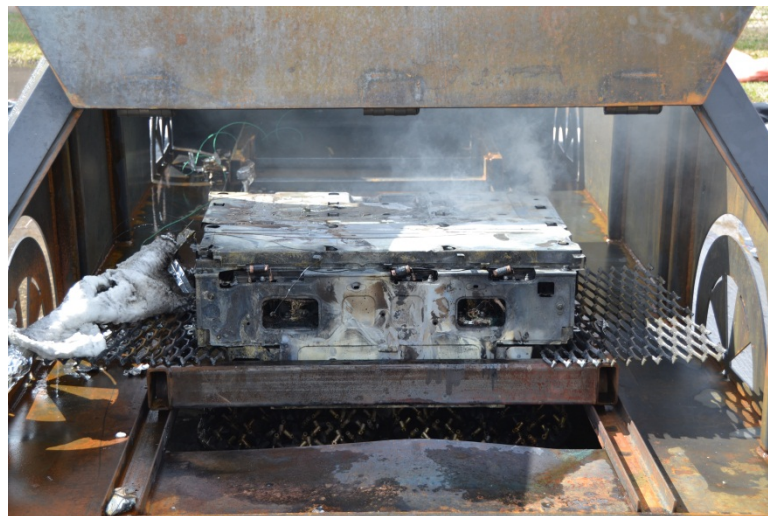
Figure 63 Test A2: suppression starts (top left); reignition and suppression (top right, bottom left); post-suppression (bottom right)

Time	Event
0:08:52	
0:09:11	Suppression starts from rear of the vehicle
0:09:48	Battery fire reignited
0:10:21 – 0:12:57	Sporadic pops with heavy white smoke off gassing
0:13:29 0 0:15:07	Would hear a “whoosh”, then observe arcing and heavy white smoke off gassing
0:15:21	Battery fire reignited
0:15:33	Firefighters attack fire from passenger side window
0:16:02 – 0:21:48	Sporadic pops with heavy white smoke off gassing
0:23:06	Battery fire reignited
0:24:26	Battery fire reignited
0:26:31	Small pop
0:26:48	Firefighters attack fire from rear of vehicle
0:27:36 – 0:37:20	Occasional small pops
0:44:00	Battery fire reignited
0:44:49	Firefighters insert nozzle directly into right vent hole on metal battery case
0:47:55	Pop
1:00:00	DAQ system off

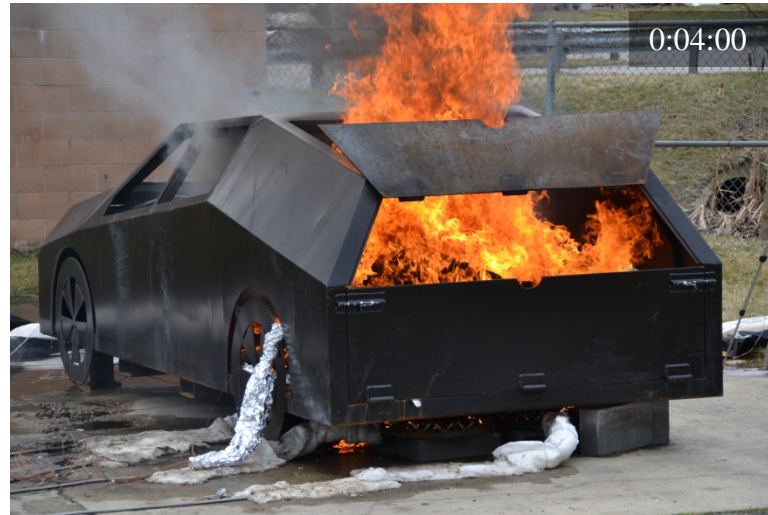
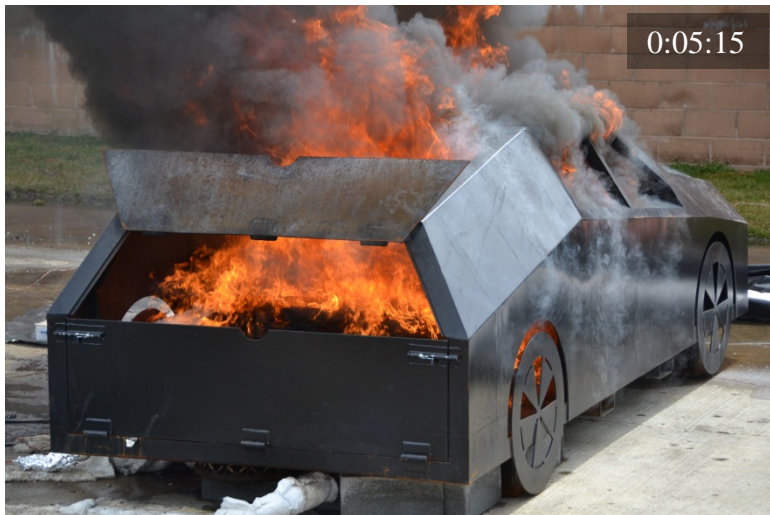
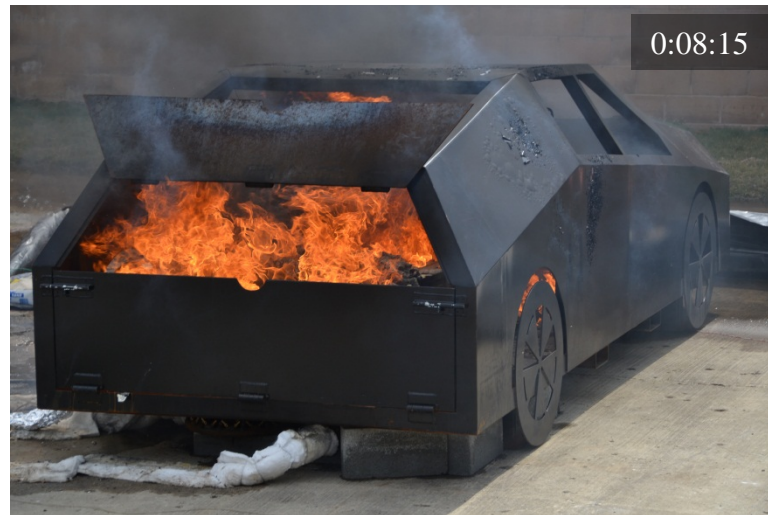
Figure 67 Test A3: ignition (top left); rear involved (top right); fully involved (bottom left); burners off (bottom right)

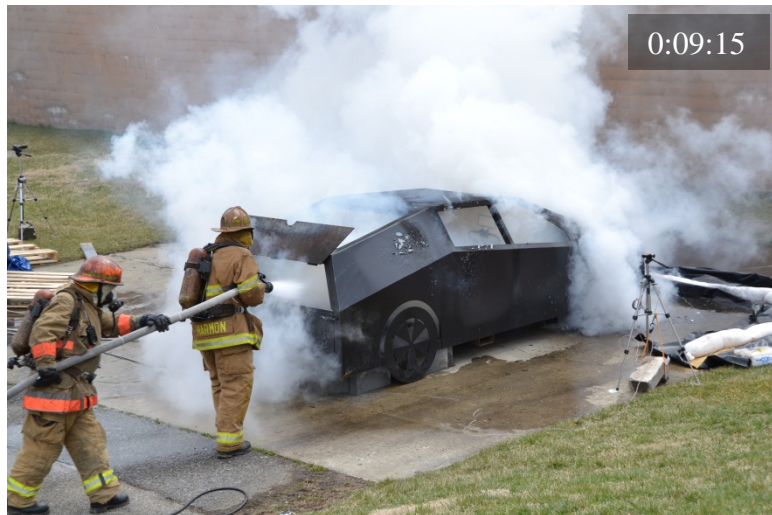
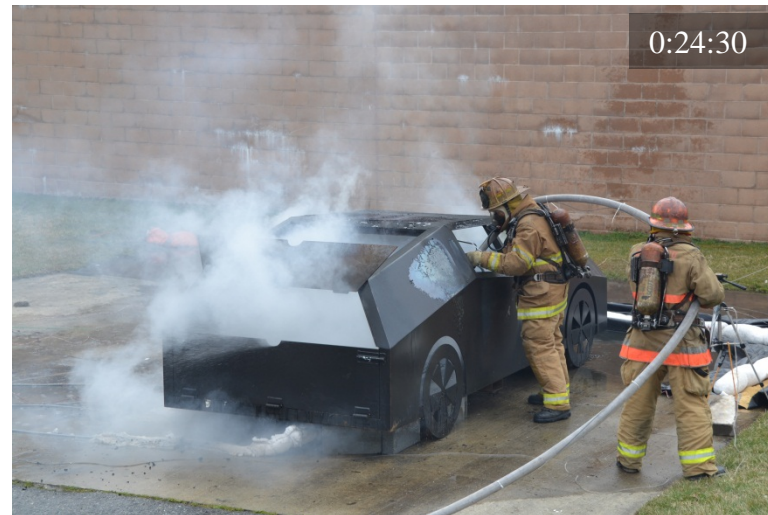
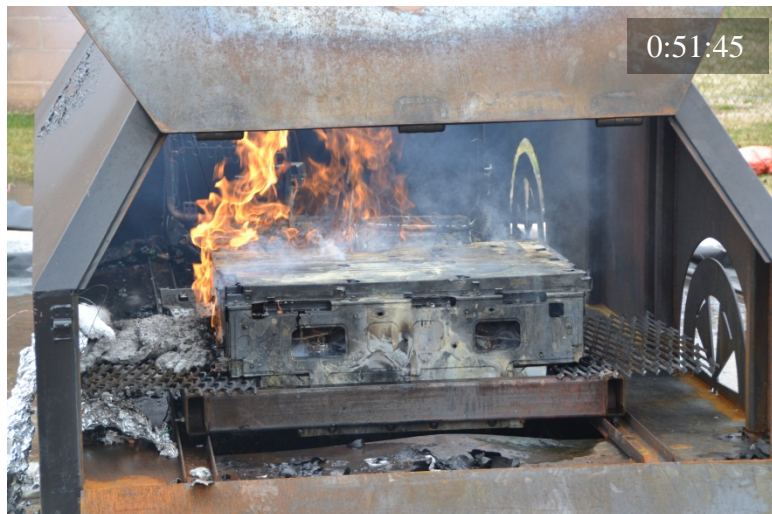
Figure 68 Test A3: Suppression starts (top left); reignition and suppression (top right, bottom left); post suppression (bottom right)

Time	Event
0:30:30	Smoke diminishing
0:30:48 – 0:39:05	Sporadic pops and white smoke off gassing
0:39:14	“Whoosh” heard, white smoke off gassing observed, battery fire reignited
0:42:51	Loud pop
0:44:30	Pops, white smoke off gassing, battery fire reignited
0:47:43	White smoke off gassing, battery fire reignited
0:50:27	Sporadic pops and white smoke off gassing
0:50:33	Battery fire reignited
0:51:21	Pops
0:51:28	Battery fire reignited
0:51:40	Pops, battery fire reignited
0:52:33	Arcing, battery fire reignited
0:53:07	Battery fire reignited
0:53:25	Battery fire reignited
0:54:32 – 0:55:37	Firefighters drizzle water over battery
0:57:04	Pops
1:00:00	DAQ system off

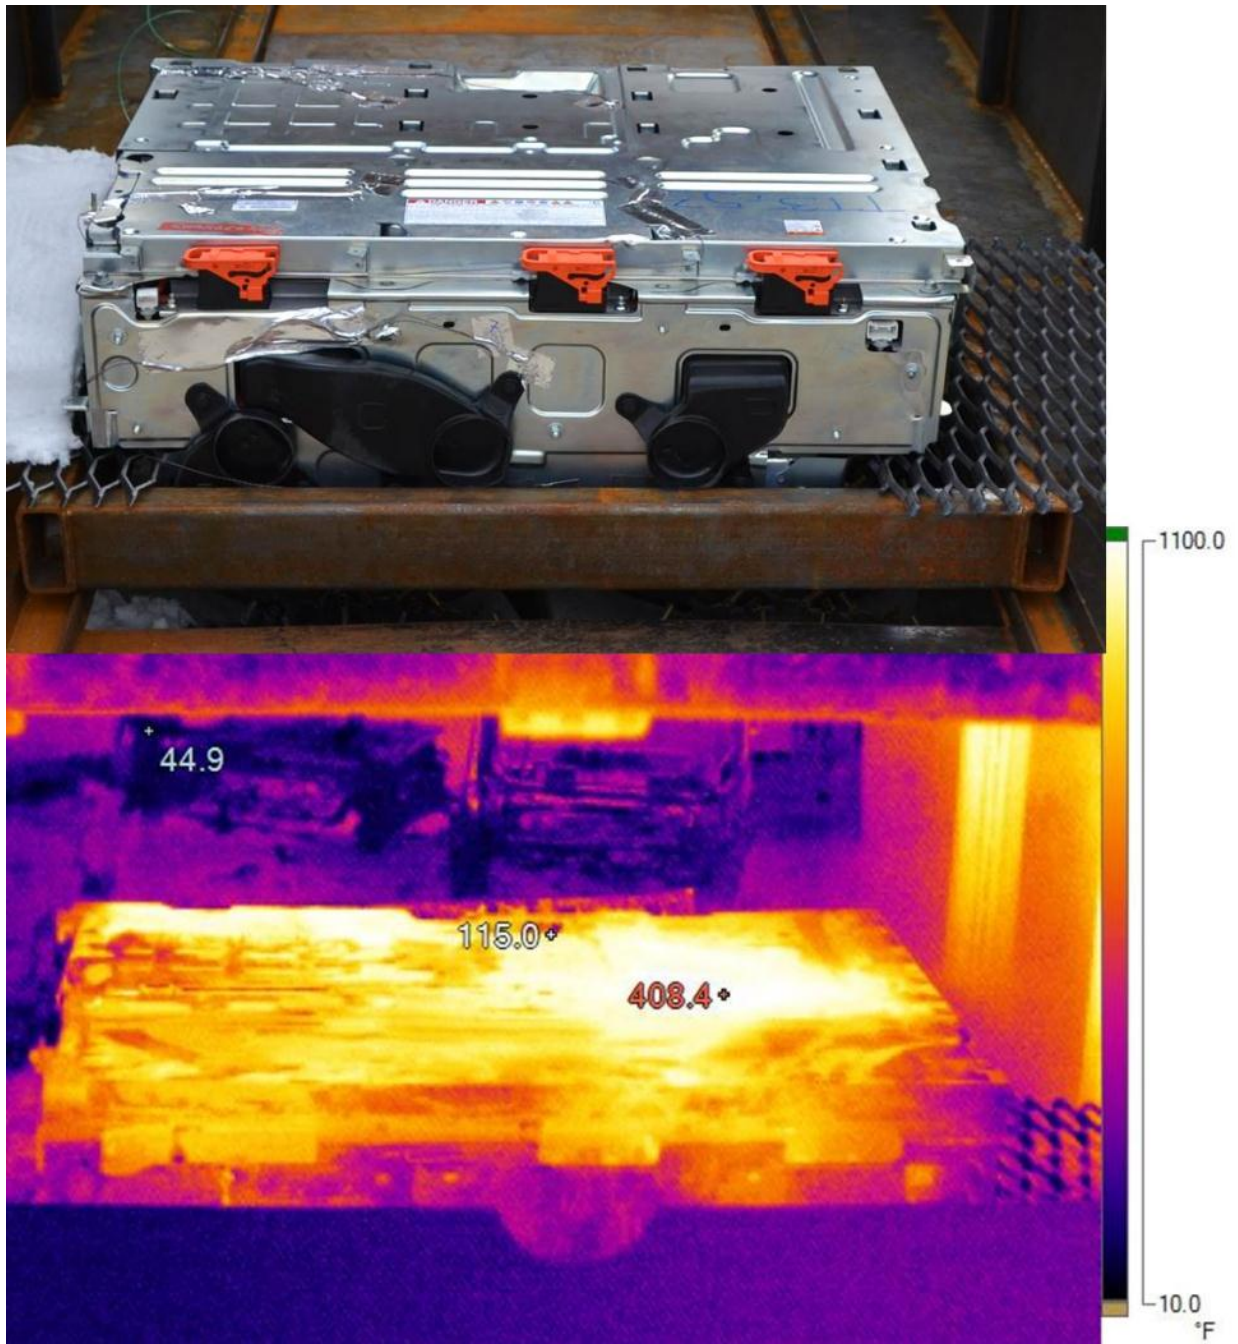
Figure 71 Battery A3 from rear of VFT (top); thermal image (same view) of Battery A3 at 41 minutes depicting the “hot spot” (bottom)

smoking and was not showing signs of any combustion. The battery was monitored for the remainder of the day and did not exhibit any additional reignitions.

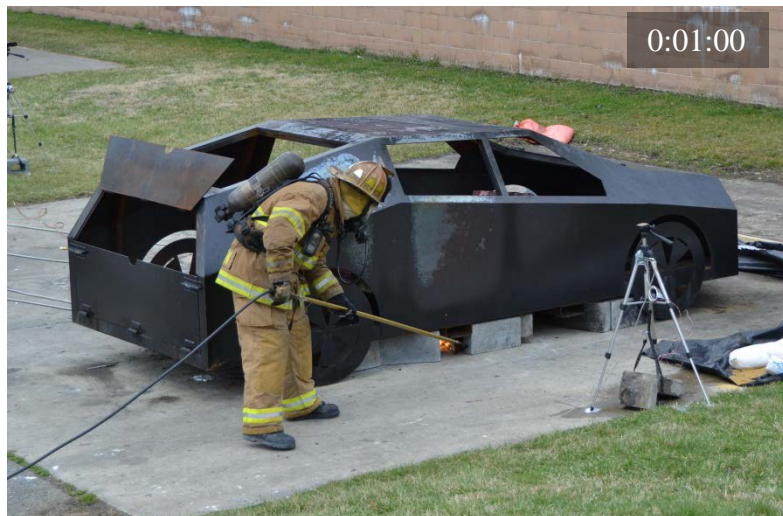
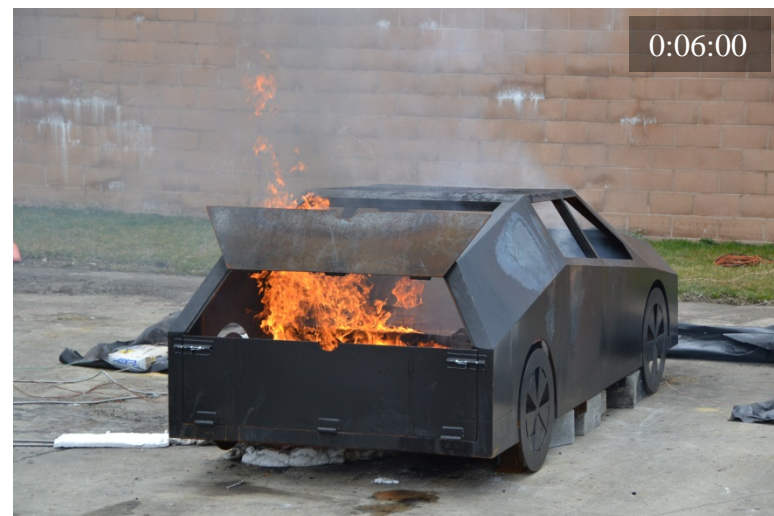
Figure 74 Test B1: ignition (top left); off gassing (top right); fully involved (bottom left); burners off (bottom right)

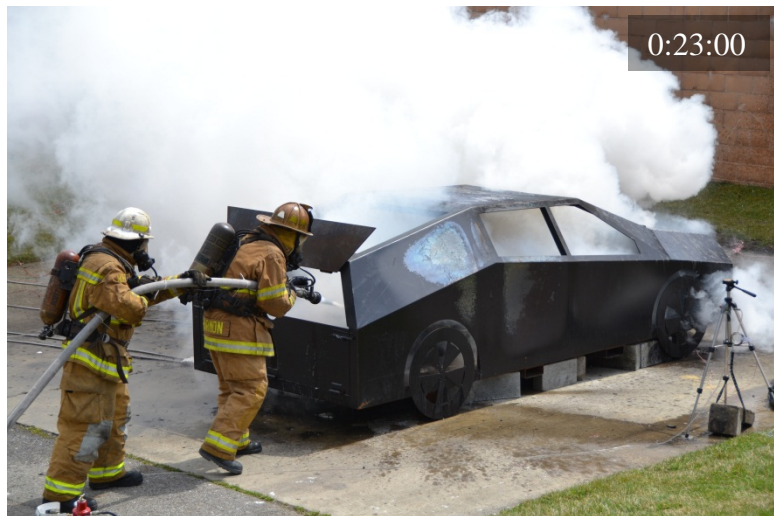
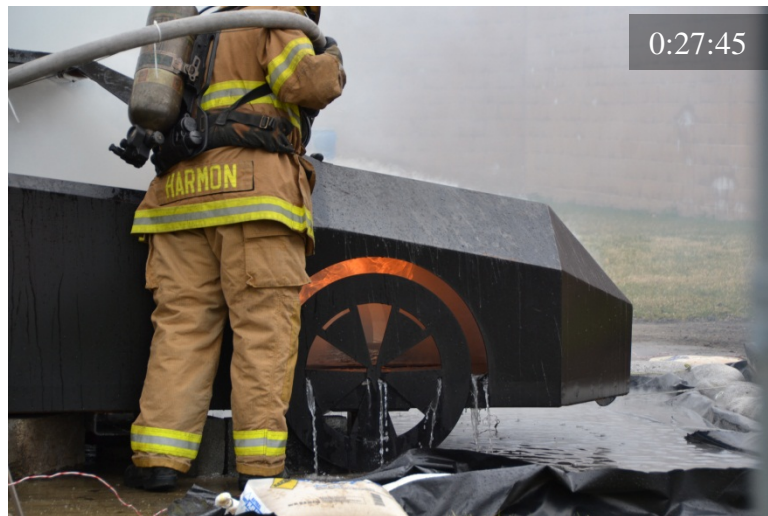
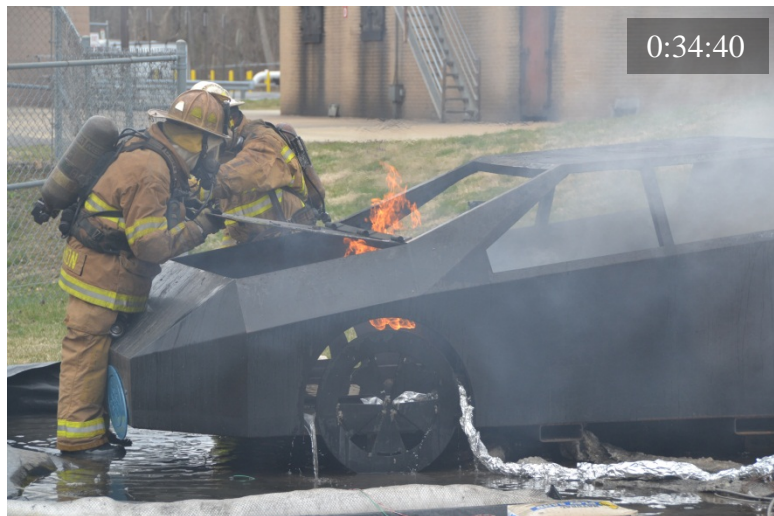
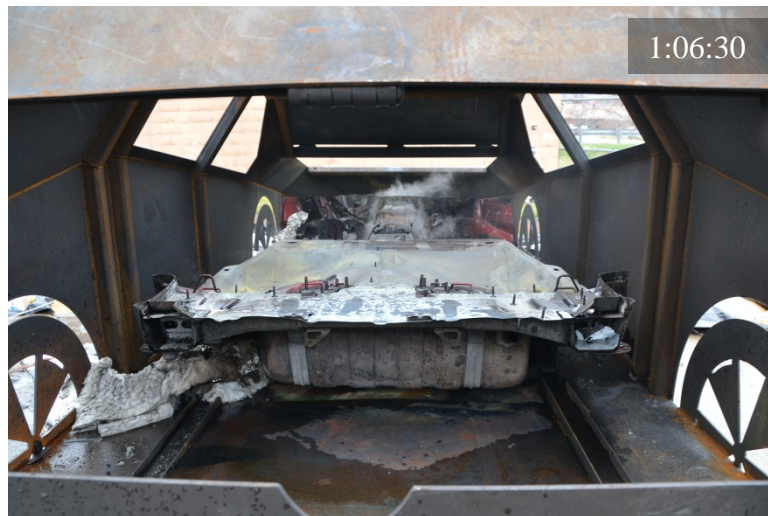
Figure 75 Test B1: suppression starts (top left); reignition and suppression (top right, bottom left); post suppression (bottom right)

0:48:34	Active suppression ends
19:00:00	DAQ system off

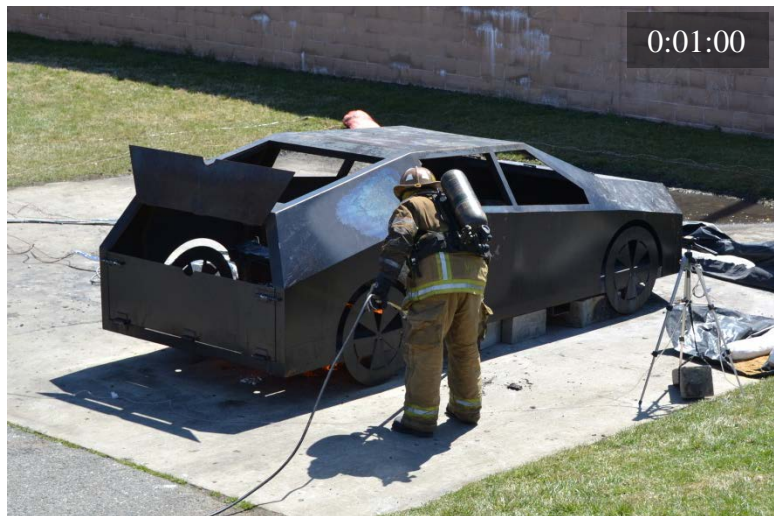
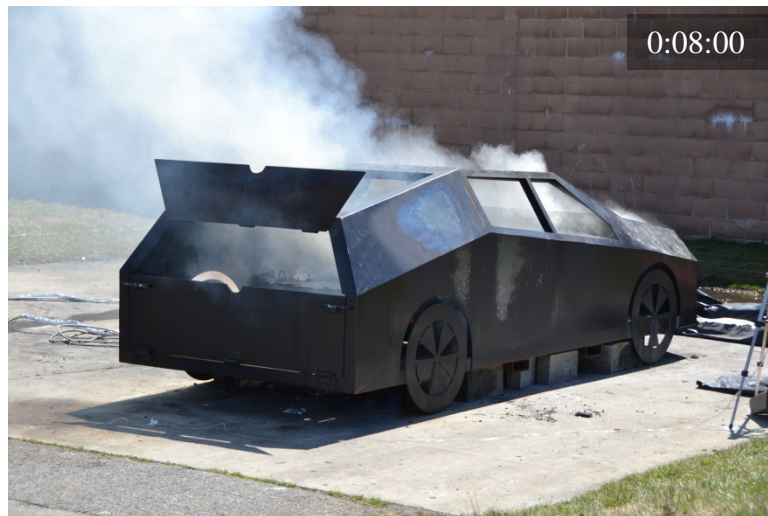
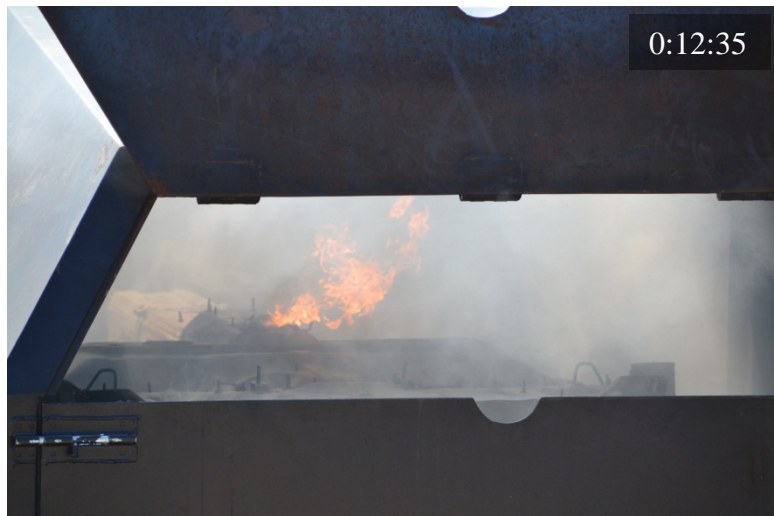
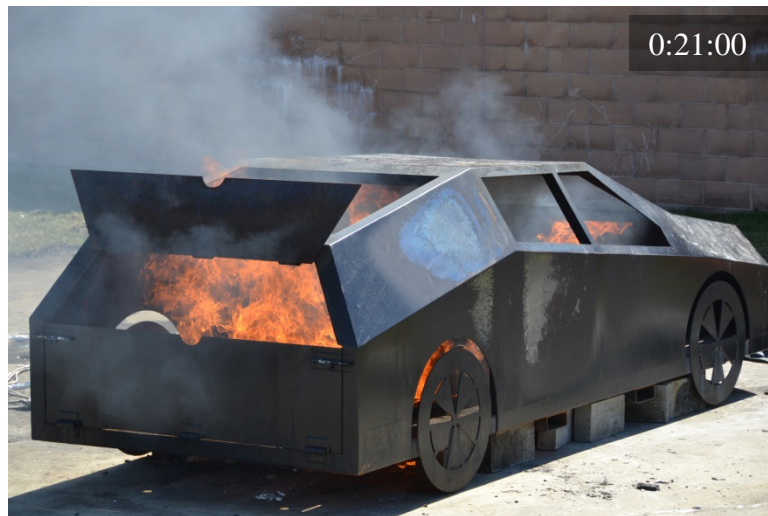
Figure 80 Test B2: ignition (top left); off gassing (top right); flames from fuse (bottom left); burners off (bottom right)

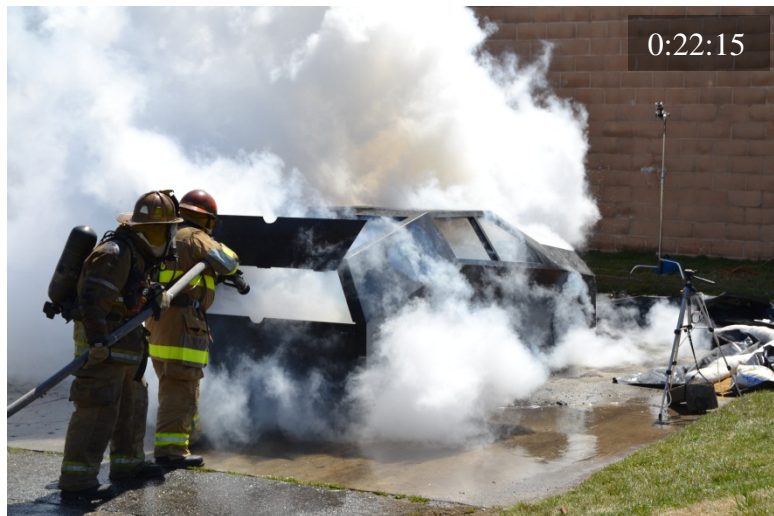
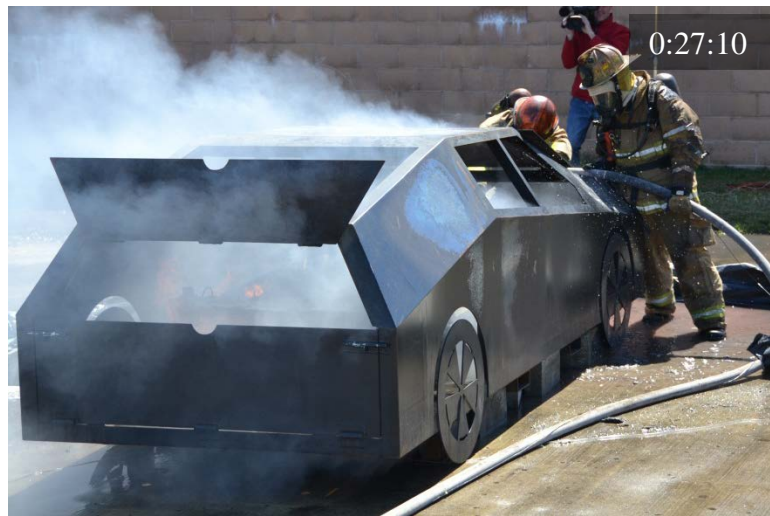
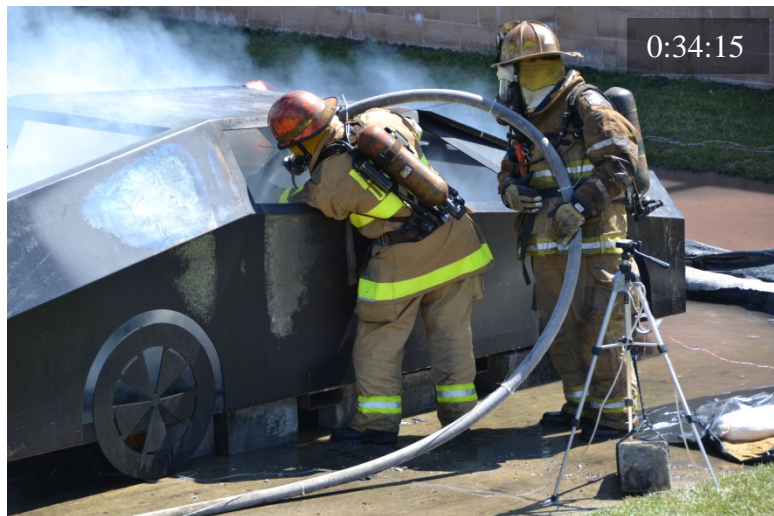
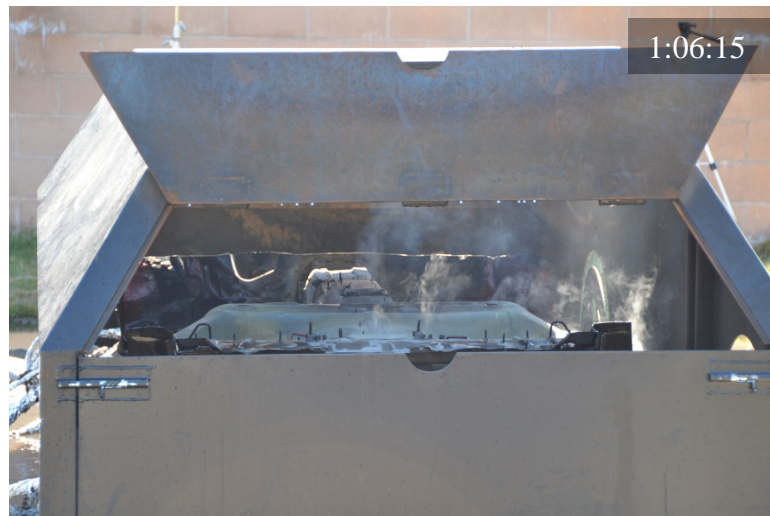
Figure 81 Test B2: suppression starts (top left); reignition and suppression (top right, bottom left); post suppression (bottom right)

Time	Event
0:38:10	Fire reignited below battery
0:38:13	Fire reignited
0:39:52	Firefighters swap out SCBA tank
0:40:41	Firefighters attack fire from rear of VFT
0:42:35	Firefighters attack fire from passenger side of VFT
0:43:35	Fire reignited below battery
0:46:33	Firefighters attack fire from front of VFT
0:55:06	Firefighters use hook to remove protective box from around the CAN bus connection area
0:56:40	Firefighters attack fire from passenger side of VFT
0:58:11	Active suppression ends
19:00:00	DAQ system off

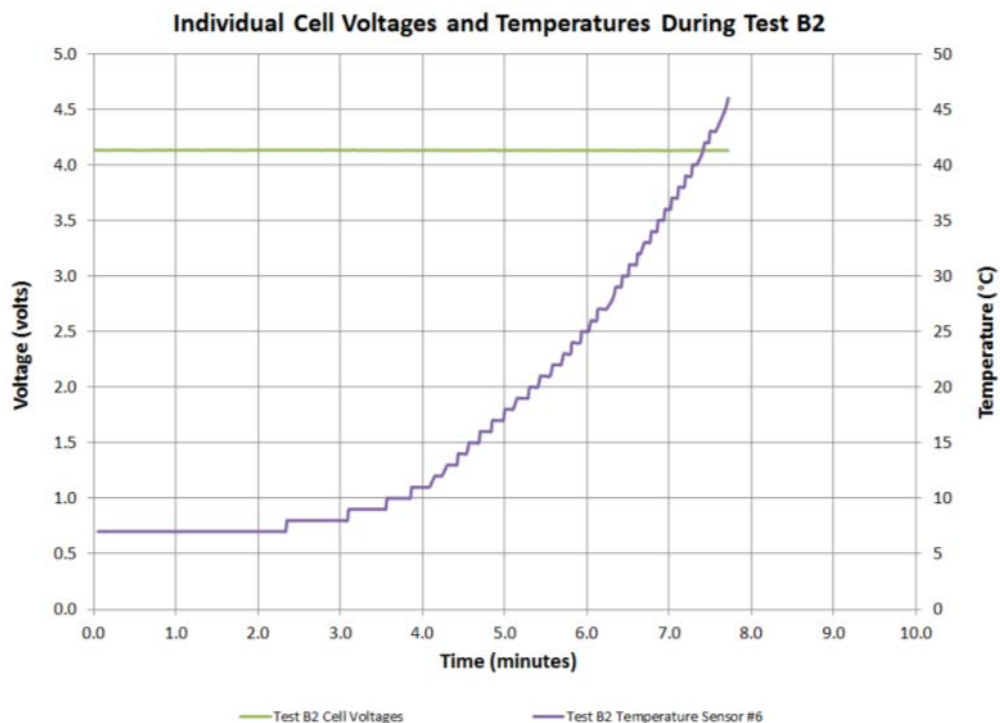
Figure 84 Internal cell voltages and temperatures during Test B2

Temperature Sensor #6 was found in the center portion of the long span of the battery by the fuse, as shown in Figure 85. None of internal TCs installed by Exponent (TCs 13-15) were in the same area as this sensor to provide any additional insight into the thermal assault the battery was under at the time. The three internal TCs remote from Sensor #6 at the time of CAN bus failure measured temperatures between 208 and 757 °F. A post-test forensic investigation revealed the failure mode was the same as was described for the HRR test (see Section 6.1.1.4), where the failure was likely an internal short in the CAN bus power supply.

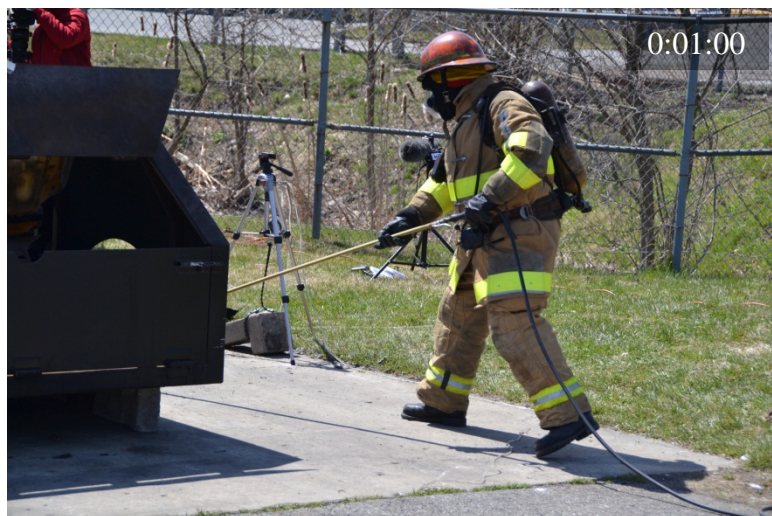
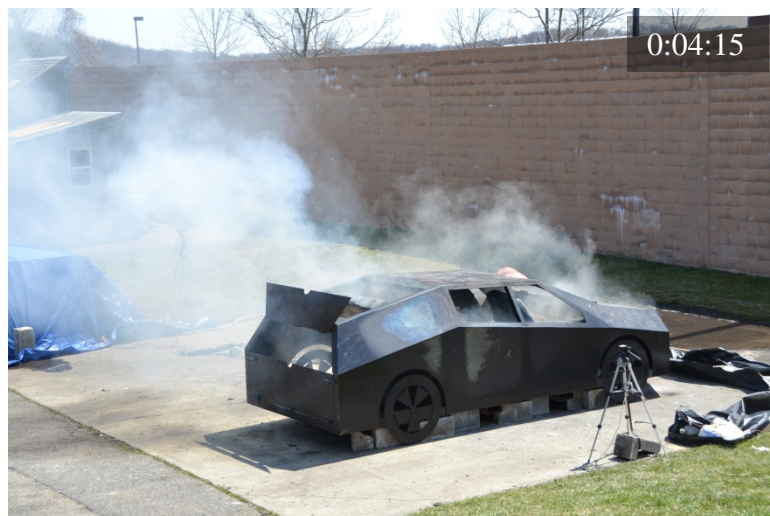
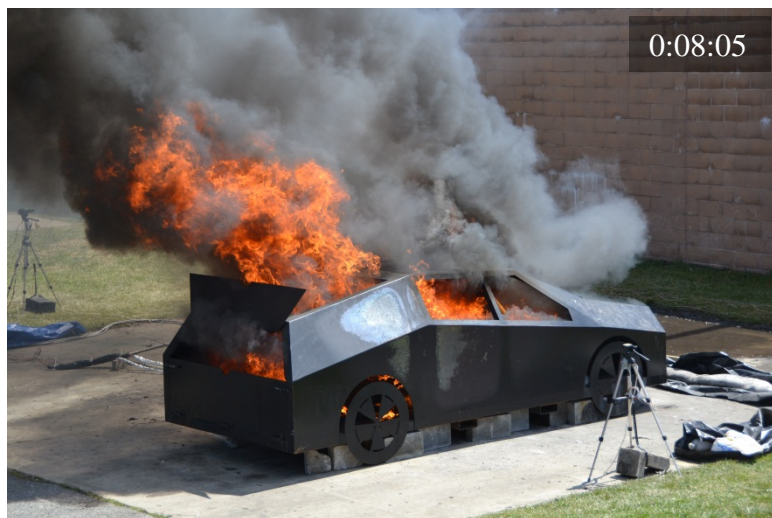
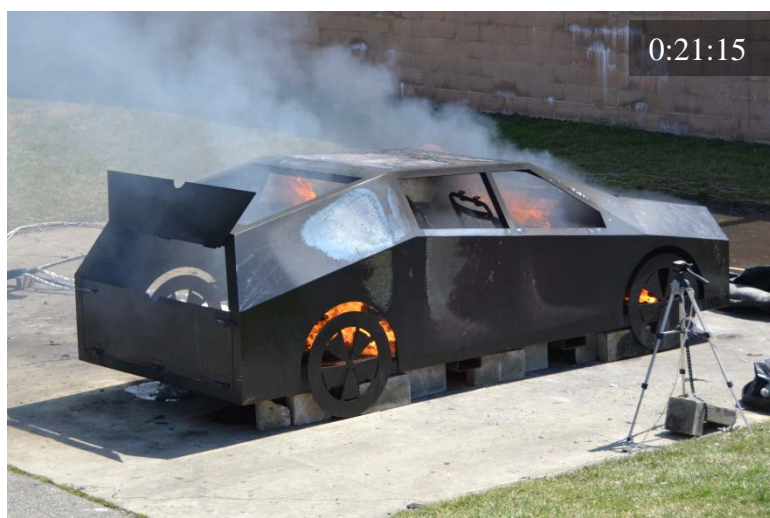
Figure 88 Test B3: ignition (top left); off gassing (top right); fully involved (bottom left); burners off (bottom right)

Time	Event
0:29:36	Firefighters attack fire from passenger side of VFT
0:30:42	Firefighters attack fire from the front of VFT
0:33:04	Firefighters attack fire from the rear of VFT
0:34:28	Firefighters attack fire from rear wheel
0:35:24	Firefighters attack fire from passenger side of VFT
0:35:58	Active suppression ends
0:38:20	Firefighters swap out SCBA tank
19:00:00	DAQ system off

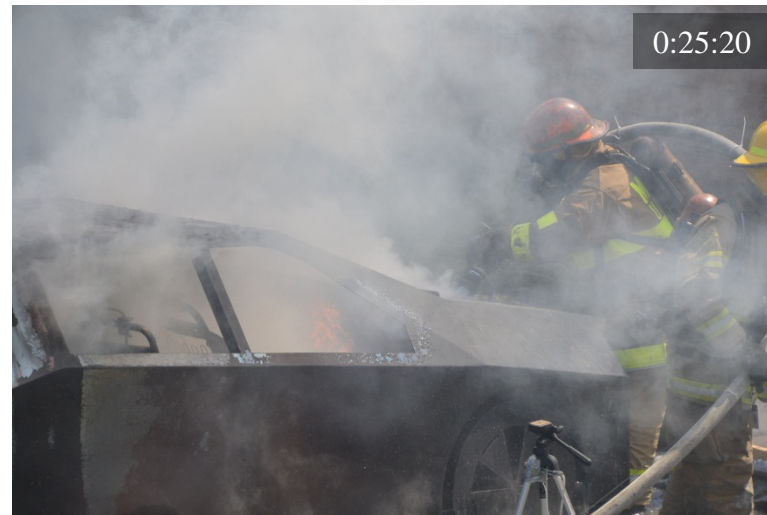
Figure 89 Test B3: suppression starts (top left); reignition and suppression (top right, bottom left); post suppression (bottom right)

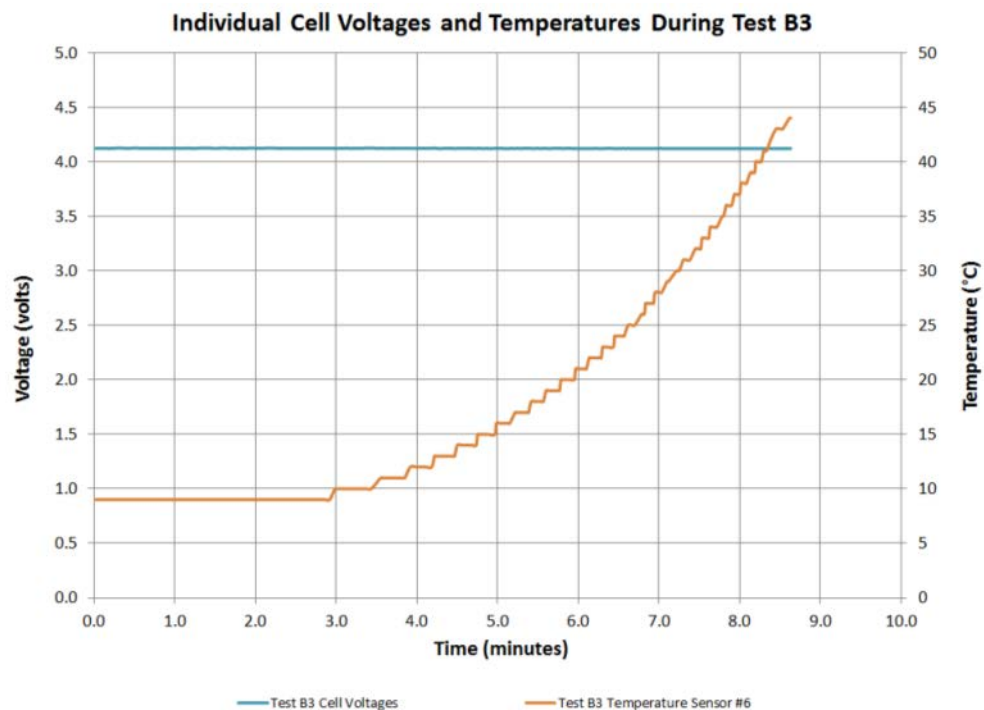
Figure 92 Internal cell voltages and temperatures during Test B3

Temperature Sensor #6 was found in the center portion of the long span of the battery by the fuse, as shown previously in Figure 85. None of the internal TCs installed by Exponent (TCs 13-15) were in the same area as this sensor to provide any additional insight into the thermal assault the battery was under at the time. The three internal TCs remote from Sensor #6 at the time of CAN bus failure measured temperatures between 232 and 405 °F. A post-test forensic investigation revealed the failure mode was the same as was described for the HRR test (see Section 6.1.1.4), where the failure was likely an internal short in the CAN bus power supply.
