Presentation 1. INL Experience With Vehicle Thermal Events

Battery Safety Council Safety Technical Discussion on The Suppression of Battery Fires Washington, DC April 2016

INL Experience with "Thermal Anomalies"

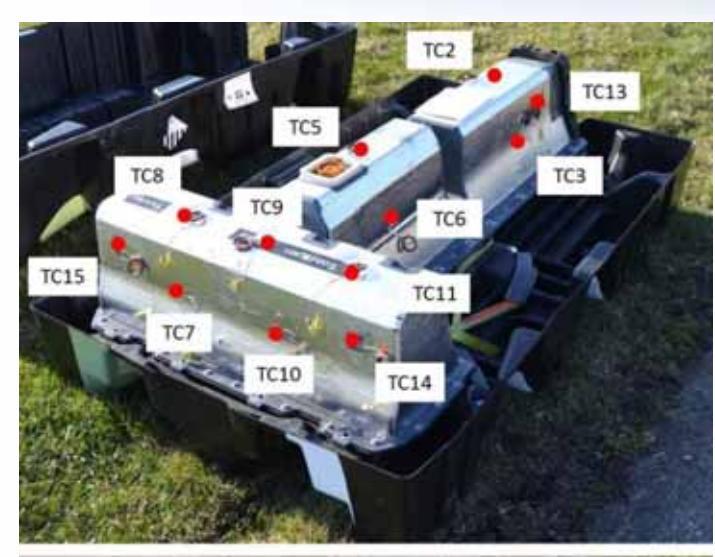
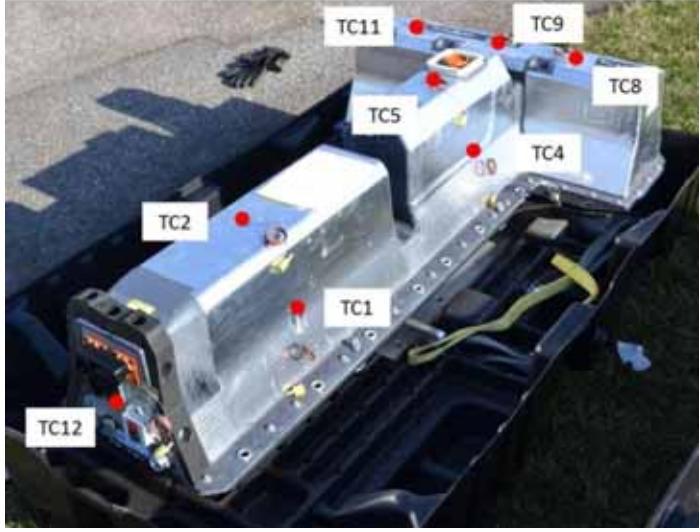
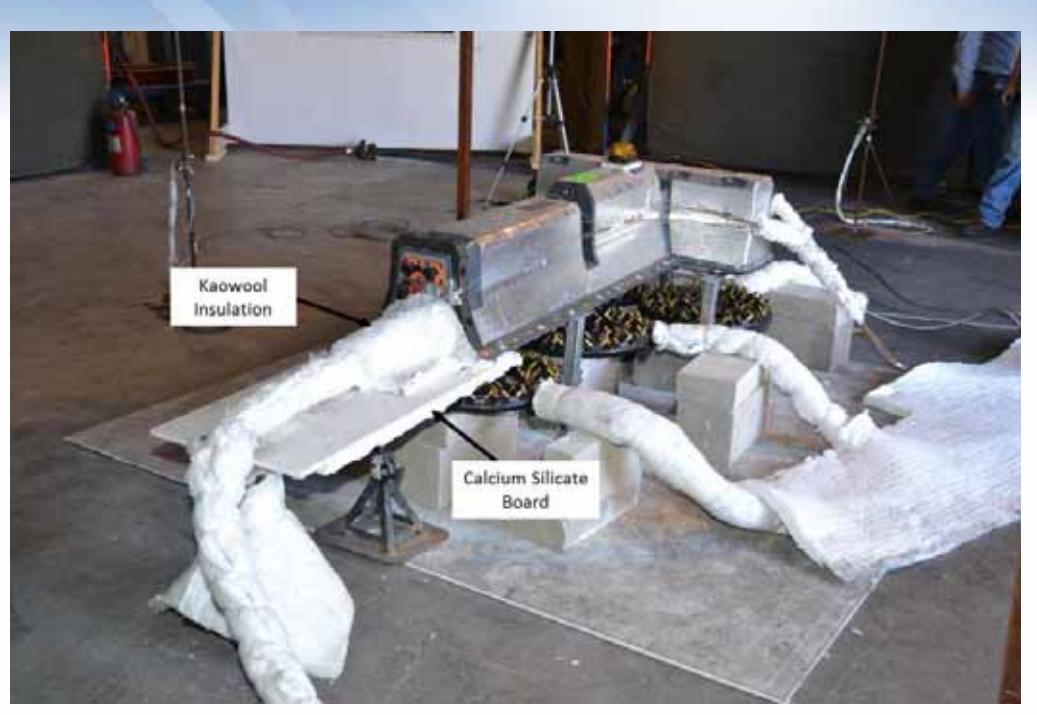
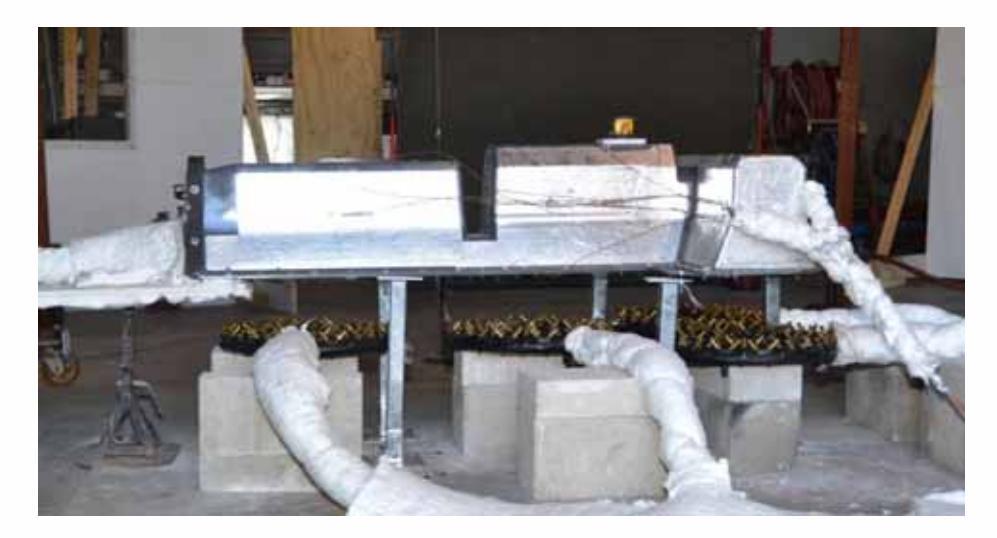
- Objective: determine the amount of energy released from the battery alone when it was ignited by an external ignition source
- Secondary objective of the testing was to verify the battery could be induced into thermal runaway with the external ignition source (propane fueled burners positioned beneath the battery) for use during the full-scale fire suppression tests and to collect data as to the indications that the battery was experiencing thermal runaway
- Based on a review of NFPA data on vehicle fire risk
 - Flammable or combustible liquids or gases were the first item ignited in 31% of U.S. highway vehicle fires, resulting in 70% of civilian deaths, 58% of civilian injuries, and 31% of the direct property damage
 - Pool fire scenario under the PEV was selected as the likely ignition scenario where the batteries become near fully involved and "burning on their own"
